## **Sustainable Weed Management in Agriculture with Laser-Based Autonomous Tools**

### **D5.3 – Equipment integration, testing, evaluation, and impact on crops and soil**

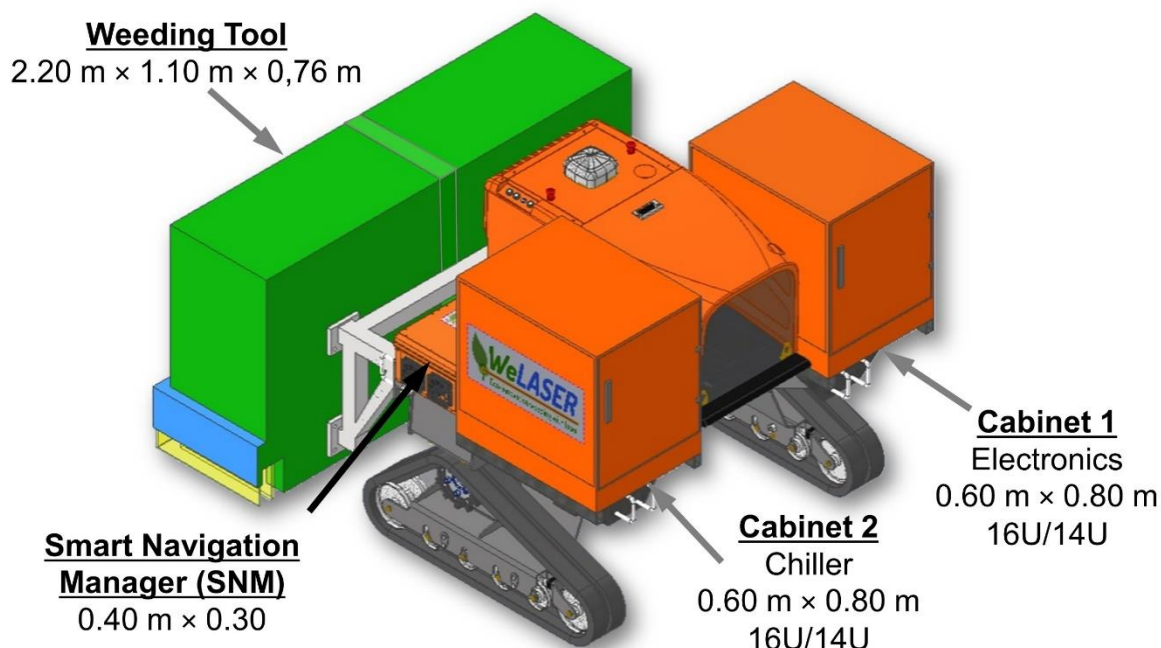
Figure 2.1 illustrates the top view of the location of the engine, the electronic cabinets, the Smart Navigation Manager (SNM), and the weeding tool. The dimensions are specified in meters (m) or height units U (1 U = 0.04445 m tall).

**Fig. 2.1. Distribution of the WeLASER components onboard the vehicle for the 2-row configuration (top view).**

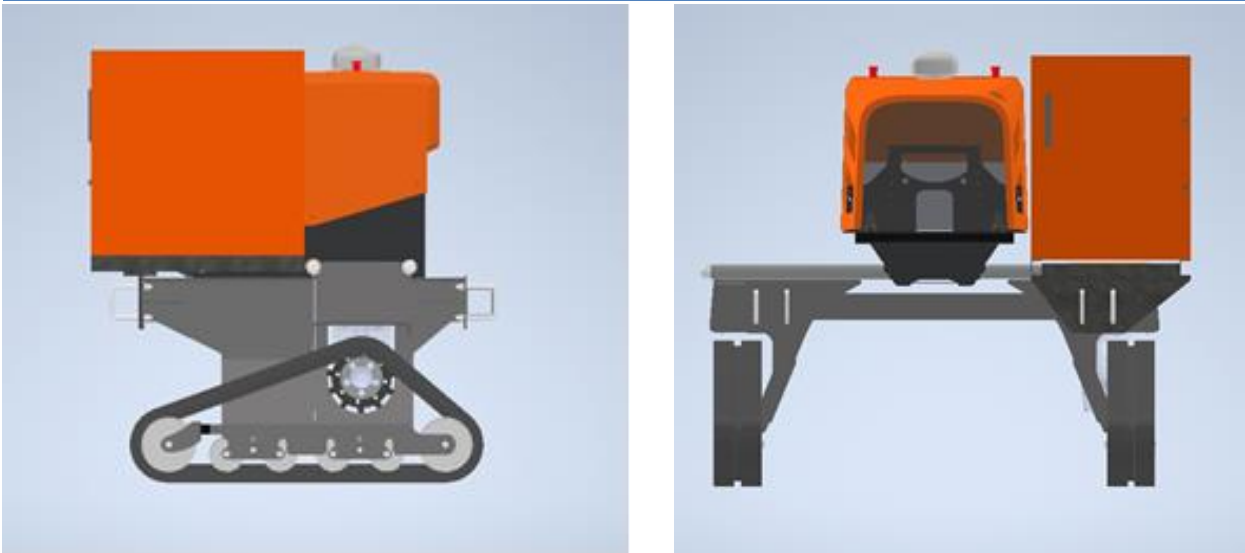
The electronic cabinets (Fig. 2.2) can be moved forward/backwards to balance the front-rear weight. Figure 2.3 illustrates the components' static mass balance (momentum) and final positions.

**Fig. 2.2. Electronic boxes (14 U).**

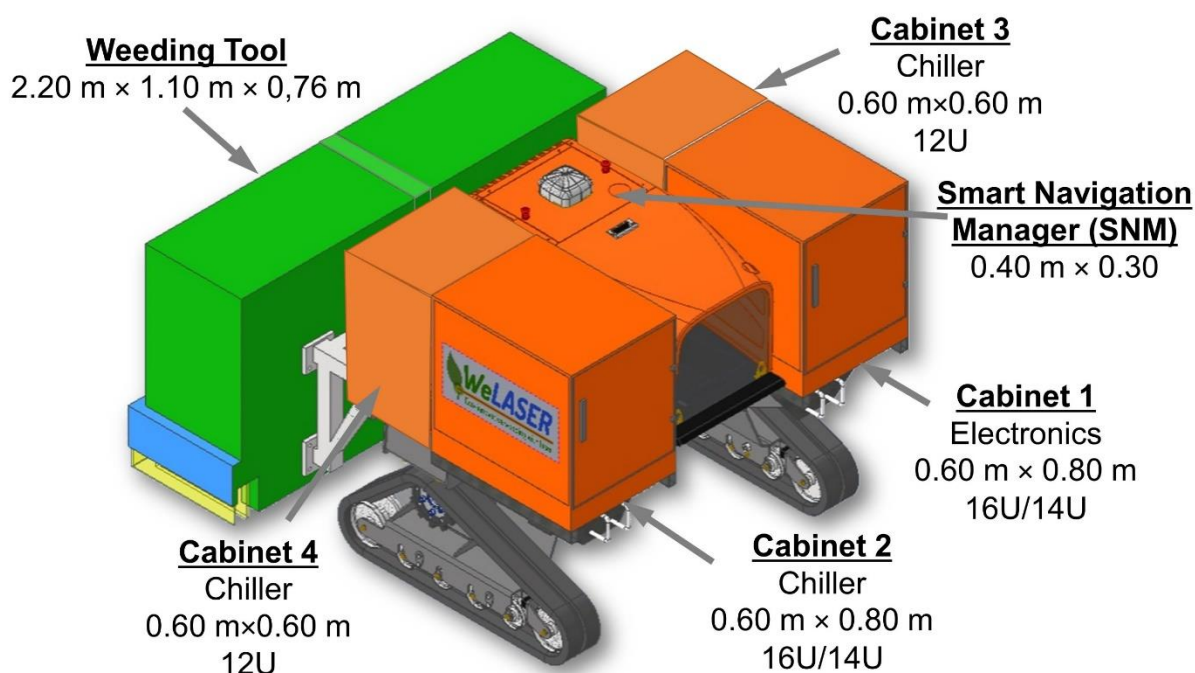
Fig. 2.4 Distribution of the WeLASER components onboard the vehicle for the 4-row configuration (top view).

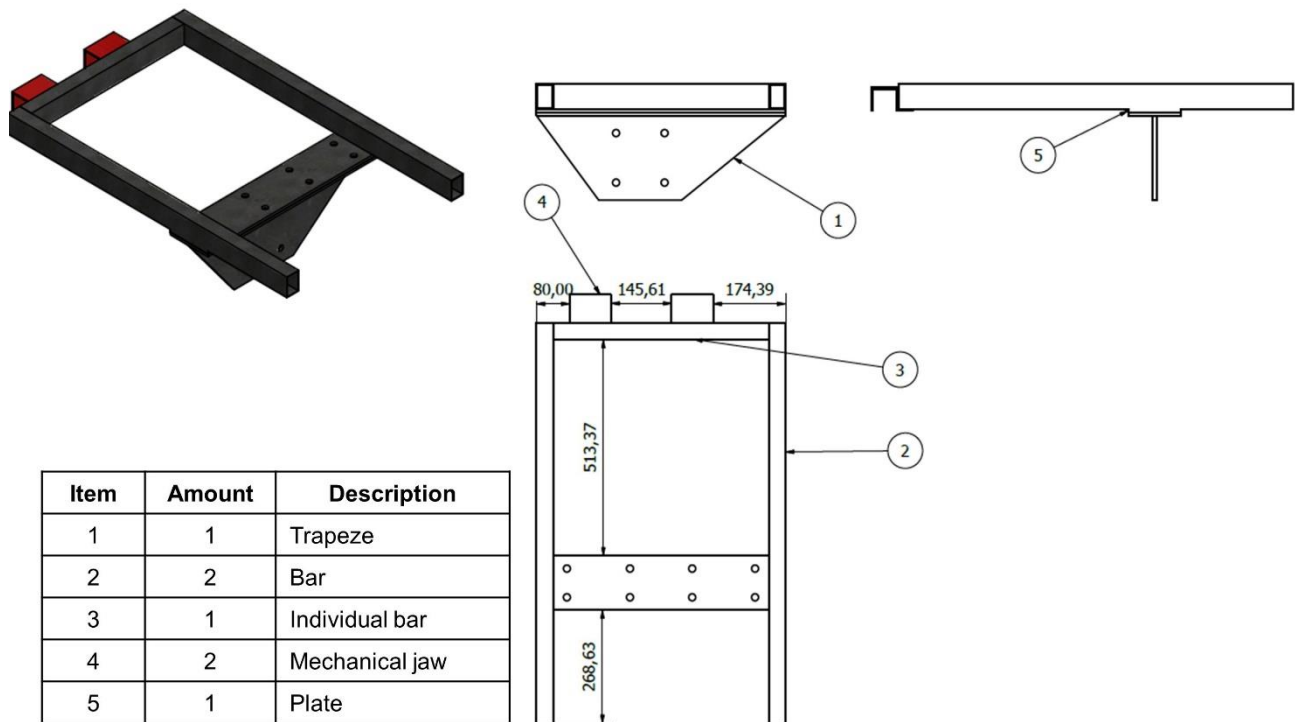
The bases described in Fig. 2.5 were designed and manufactured to attach the electronic cabinets to the mobile platform. Their weights are indicated in Table 2.2.

**Fig. 2.5. Cabinet bases.**

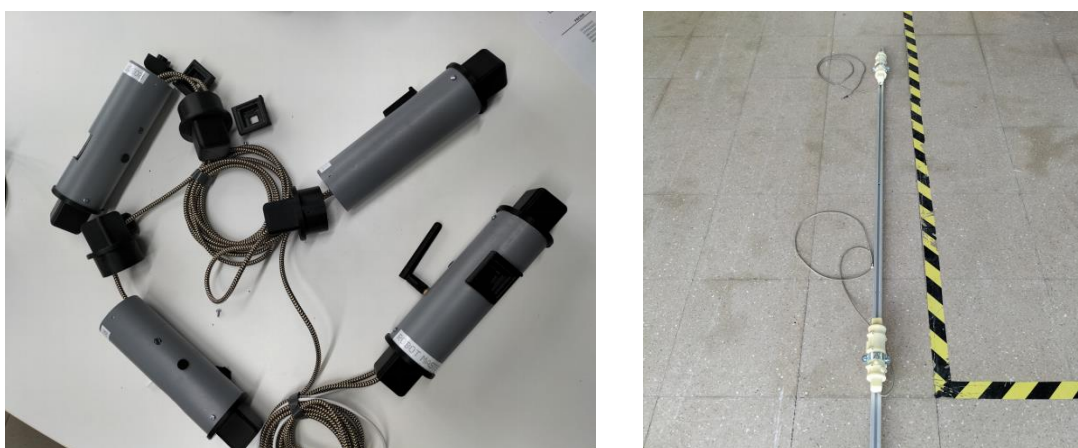
This class of devices is not provided with an autonomous power supply as they are connected directly to the robot power system. They may receive signals from the robot to take snapshots upon request. To the scope, a camera (Master, front left) has been connected to the robot to be plugged into the robot power supply (12V) and a serial cable to communicate with its controller (by ROSSERIAL interface). The master then communicates with the other 3 slave cameras (Front right, Rear right, Rear left). Every camera autonomously sends its images via WiFi (Robot AP) to the Robot server FTP, where a service (daemon) is also running to send the images to the main server (cloud). The robot cameras have been applied to the robot so it can be easily removed (Fig 2.6).

**Fig. 2.6. Robot cameras (left) and their application bar (right).**

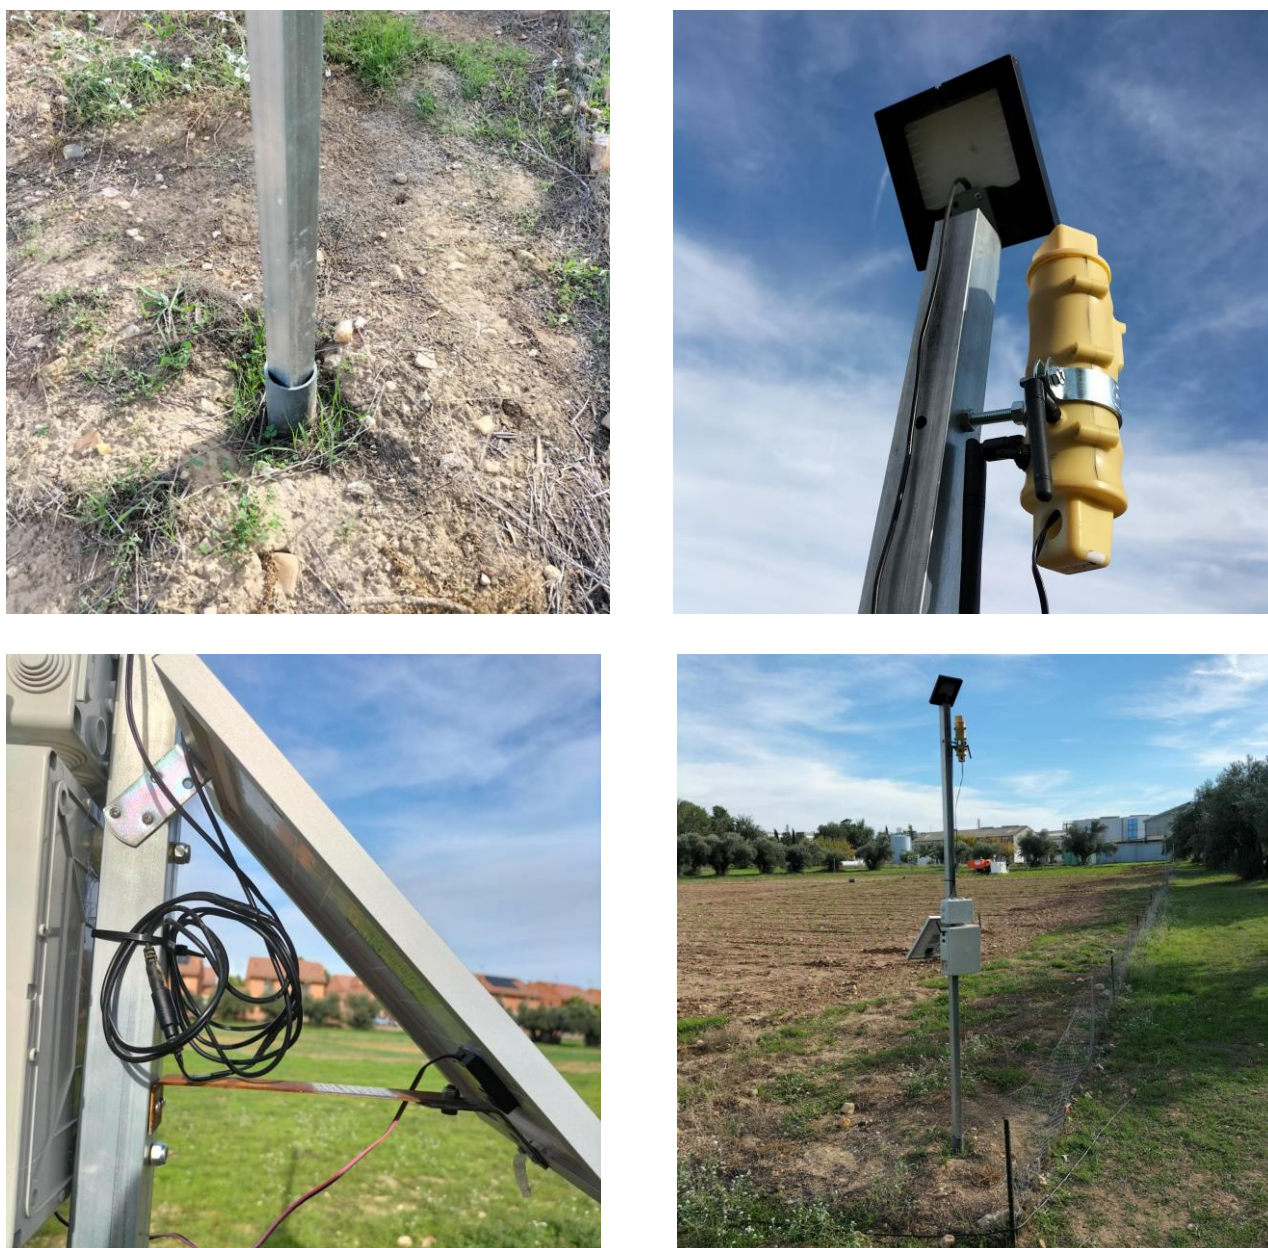
This class of devices is provided with an autonomous power supply harvesting energy from a (circa 100 cm<sup>2</sup>) external photo voltaic (PV) cell. To host the PV panel, an 8 square section profile pole (200×5×5 cm) has been prepared (at CSIC facilities). In the experimental field (at CSIC), 8 boreholes have been made to host 8 PVC pipes (40×8 cm external diameter) whose internal diameter was well fitting the squares poles, allowing them to set in place easily, remove and rotate the poles. The poles were also provided with support for the camera nodes (see Fig. 2.7).

**Fig. 2.7. Field cameras and their application.**

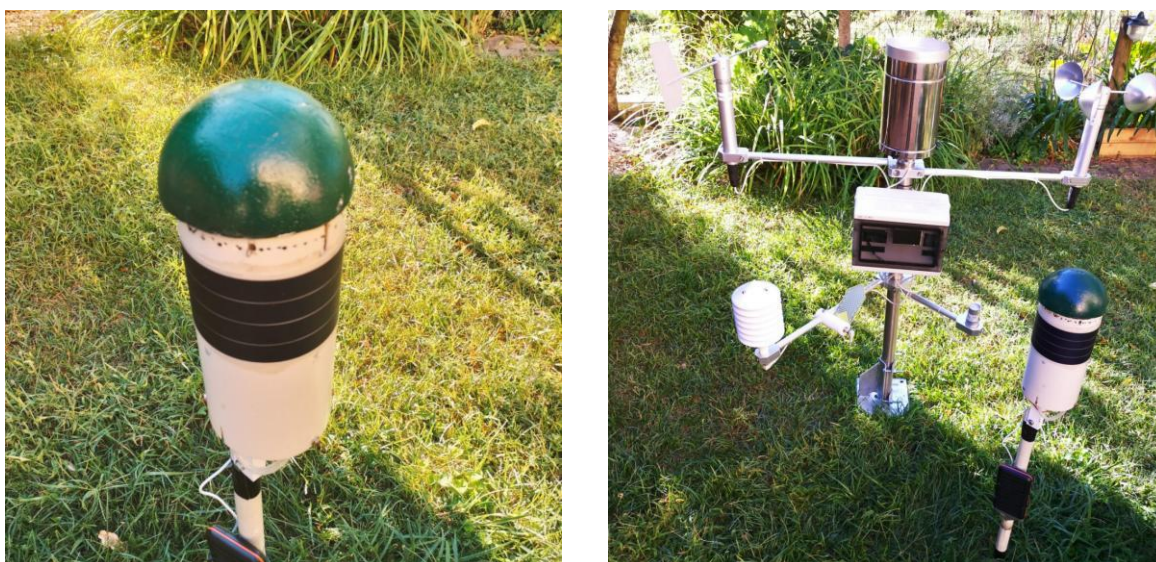
A low-cost, low-power, low-maintenance weather station has been designed to provide the techno-ecosystem with a collector of information detailing weather data for more precise decision-making. The Weather Station harness the same base technology of other nodes and, to address the characteristic mentioned above, includes recent approaches for wind and precipitation measurement (see Fig. 2.8).

**Fig. 2.8. Weather Station (left) beside the Standard one used for calibration (right).**

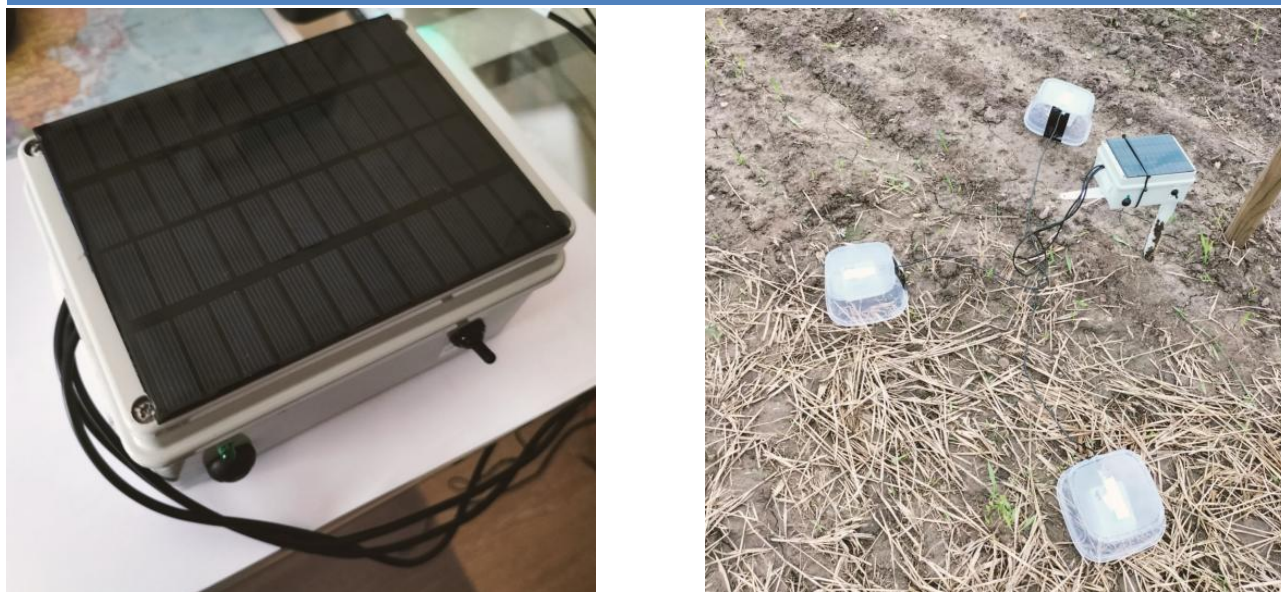
A portable and easily configurable device for the measurement of atmospheric concentration of CO<sub>2</sub>, Relative Humidity and Temperature, capable of observing till 6 points, has been designed accounting for the growing address to evaluate fluxes of CO<sub>2</sub> and Water from cropped surfaces see Fig. 2.9).

**Fig. 2.9. ETRometer box (left) and its 3-sensor configuration (right).**

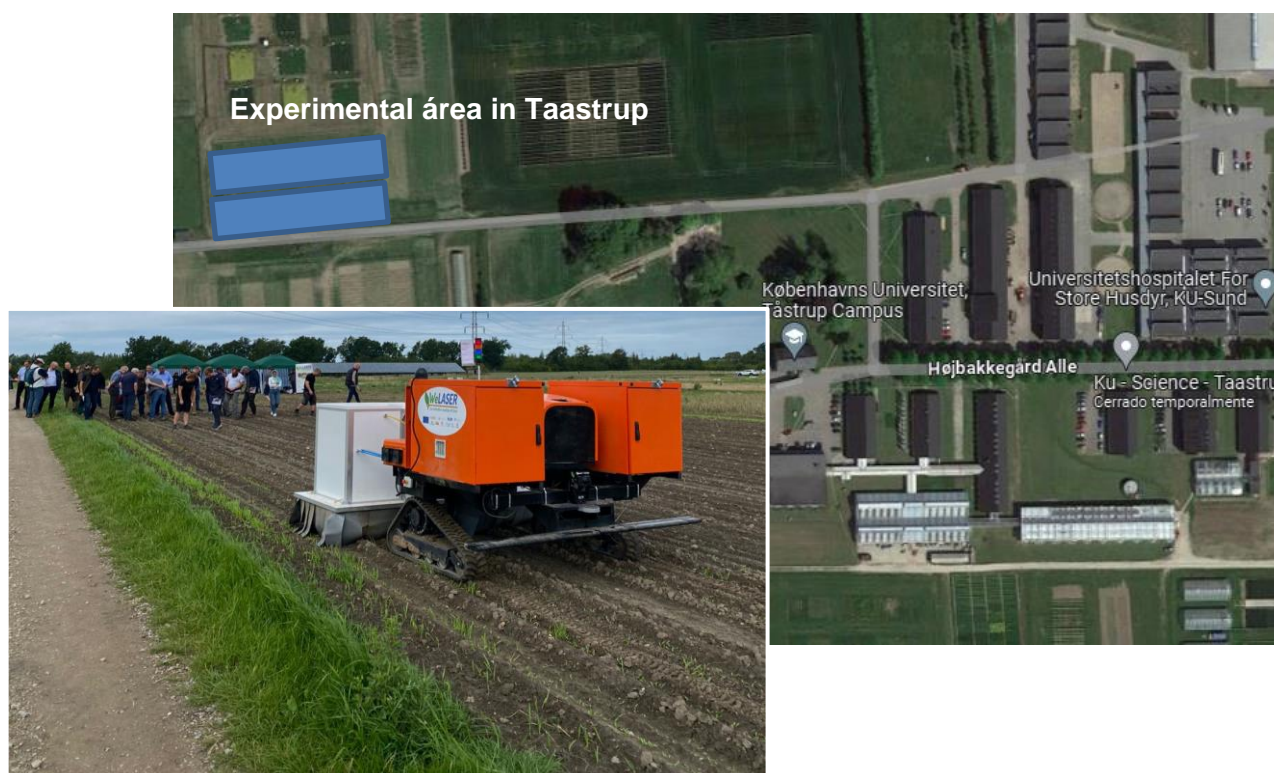
**Fig 3.2. Experimental field in Taastrup, Denmark.**

Figure 3.2 shows the experimental field and the distribution of the areas and sections.

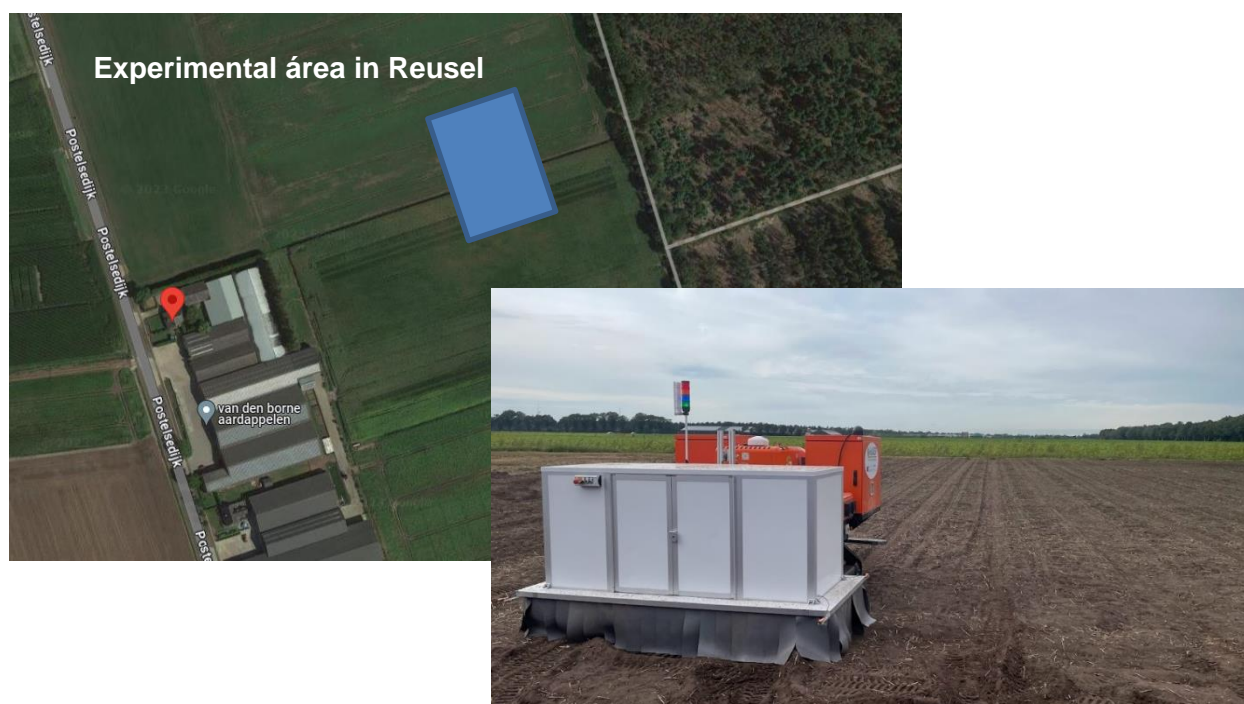
**Fig 3.3. Experimental field in Reusel, The Netherlands.**

VDBP provided a large booth and a 37×15-m<sup>2</sup> field with maize () and sugar beet () plants to test the WeLASER weeding system in Reusel, The Netherlands (5°10'32.241"N, 51°19'12.298"W). From August 22 to 26, 2023, the developers of the WeLASER consortium worked together to tune the system (training the perception and targeting systems) and conducted tests and experiments for system validation and assessment. Figure 3.3 shows the experimental field and the distribution of the areas and sections.

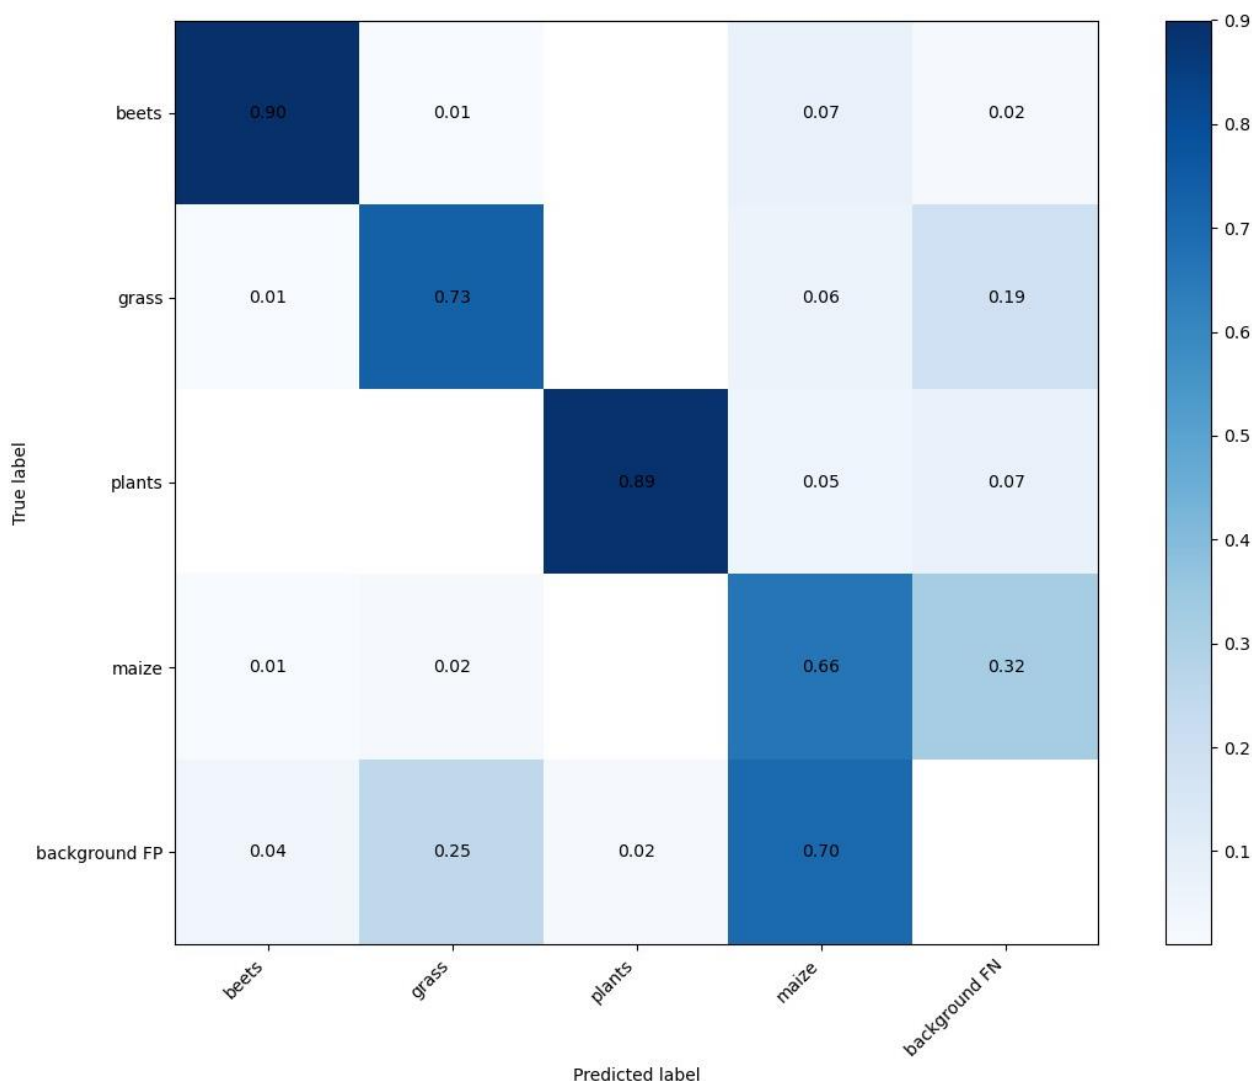
**Fig. 3.4. Confusion Matrix: Crop-weed classification accuracy for beets, maize, grass weeds, other plants, and background.**

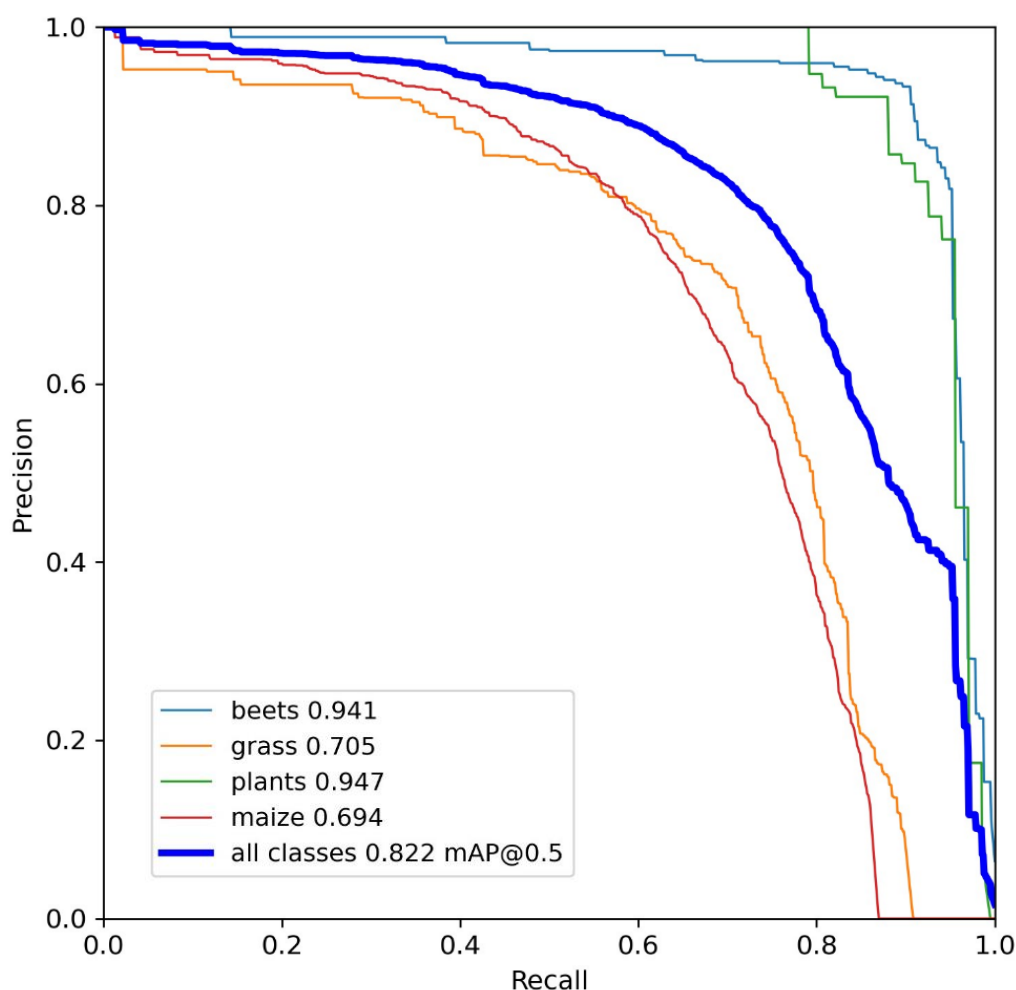
**Fig. 3.5. Precision-recall curve: Illustrating the AI's balance between accuracy and detection rate.**

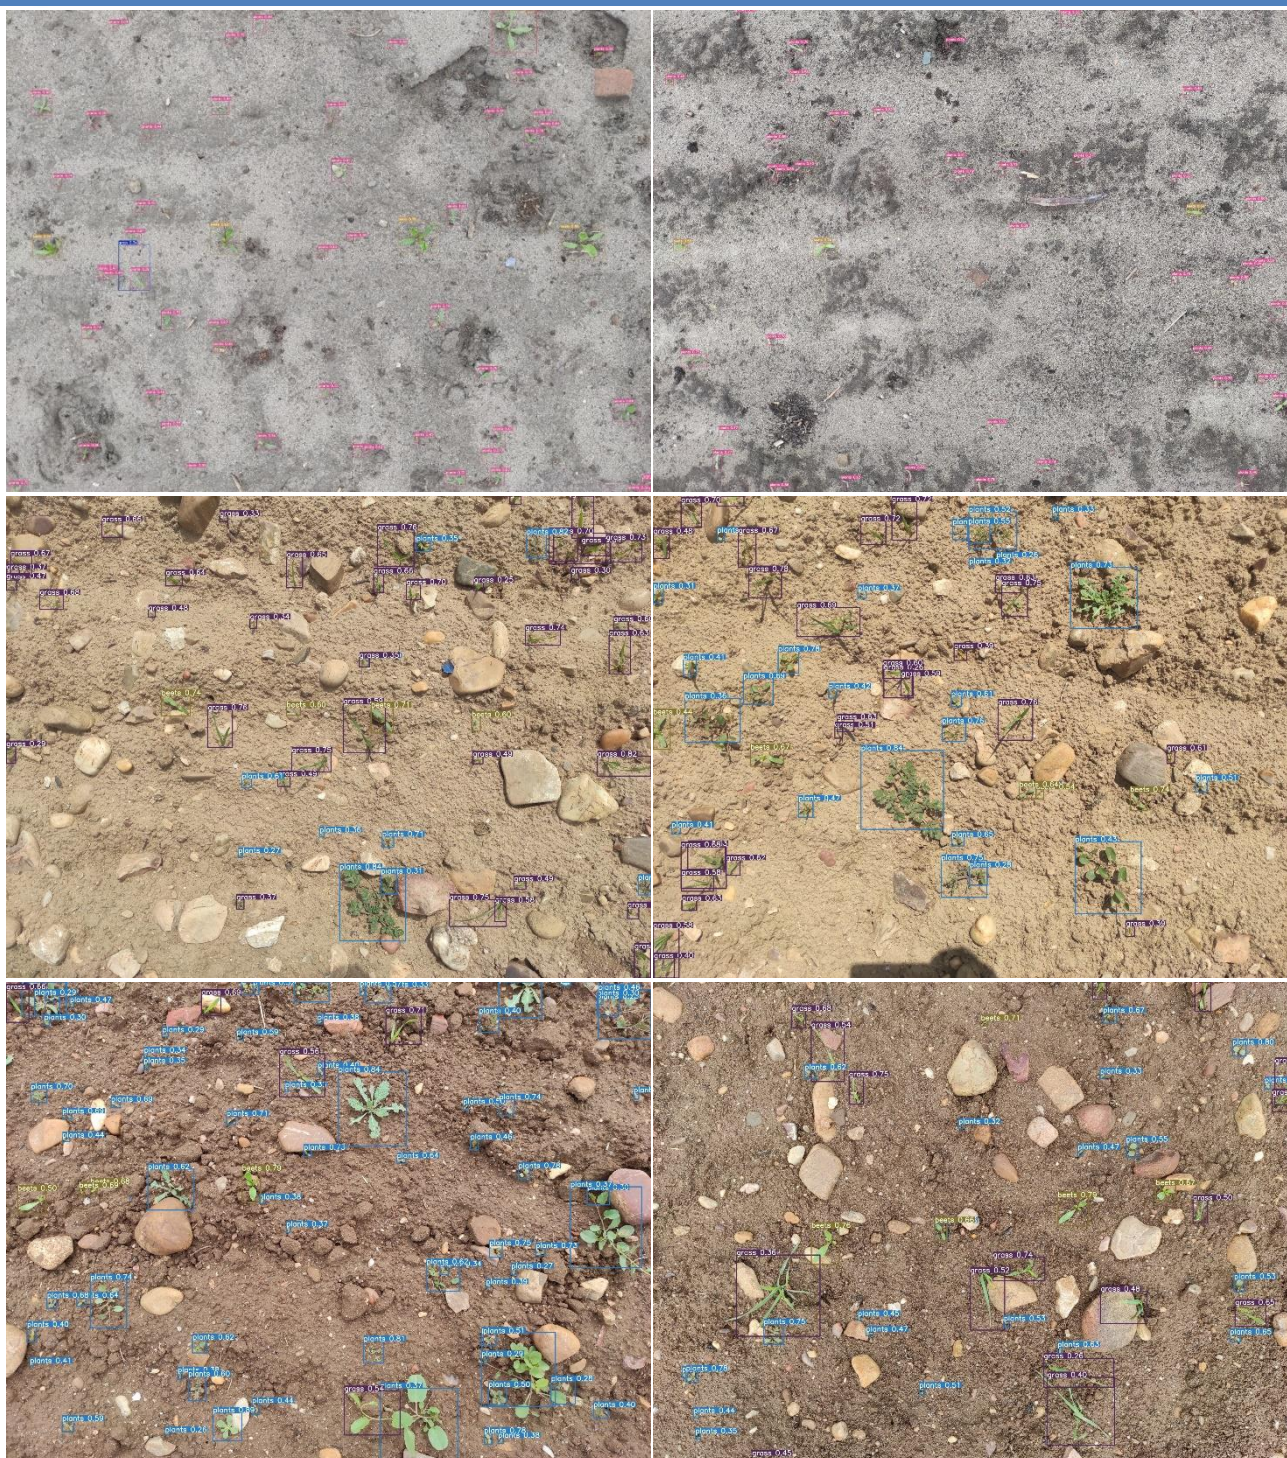
The real-world applicability of the AI system is further demonstrated through a series of sample images from different test fields across Europe, including images from German (top row) and Spanish fields under various environmental conditions (see Fig. 3.6). These images showcase the AI's weed detection capabilities under varied field conditions, highlighting its adaptability and versatility in diverse environments.

Specifically, the images display the AI's proficiency in detecting weeds in sugar beet fields. Challenges encountered include identifying very young or small weeds, differentiating weeds from stones, and recognizing various weed species, including many-leaved, possibly perennial weeds. The AI's ability to adapt to the different weed spectra and the varying appearances of the same crop under different growth conditions is evident.

**Fig. 3.6. Sample images: Demonstrating the AI's weed detection in different test field conditions. Top row: sugar beet field in Germany with sandy soil and fairly optimal growth stage of the weeds for laser weeding. Crop plants are marked in mustard yellow, dicot weeds in pink, and monocot weeds in blue. Mid and bottom row: sugar beet field in Spain with many stones and weeds in a wider range of growth stages including perennial weeds. The sugar beet crop is again mustard-coloured, dicotyledon weeds in blue and monocotyledon weeds in purple.**

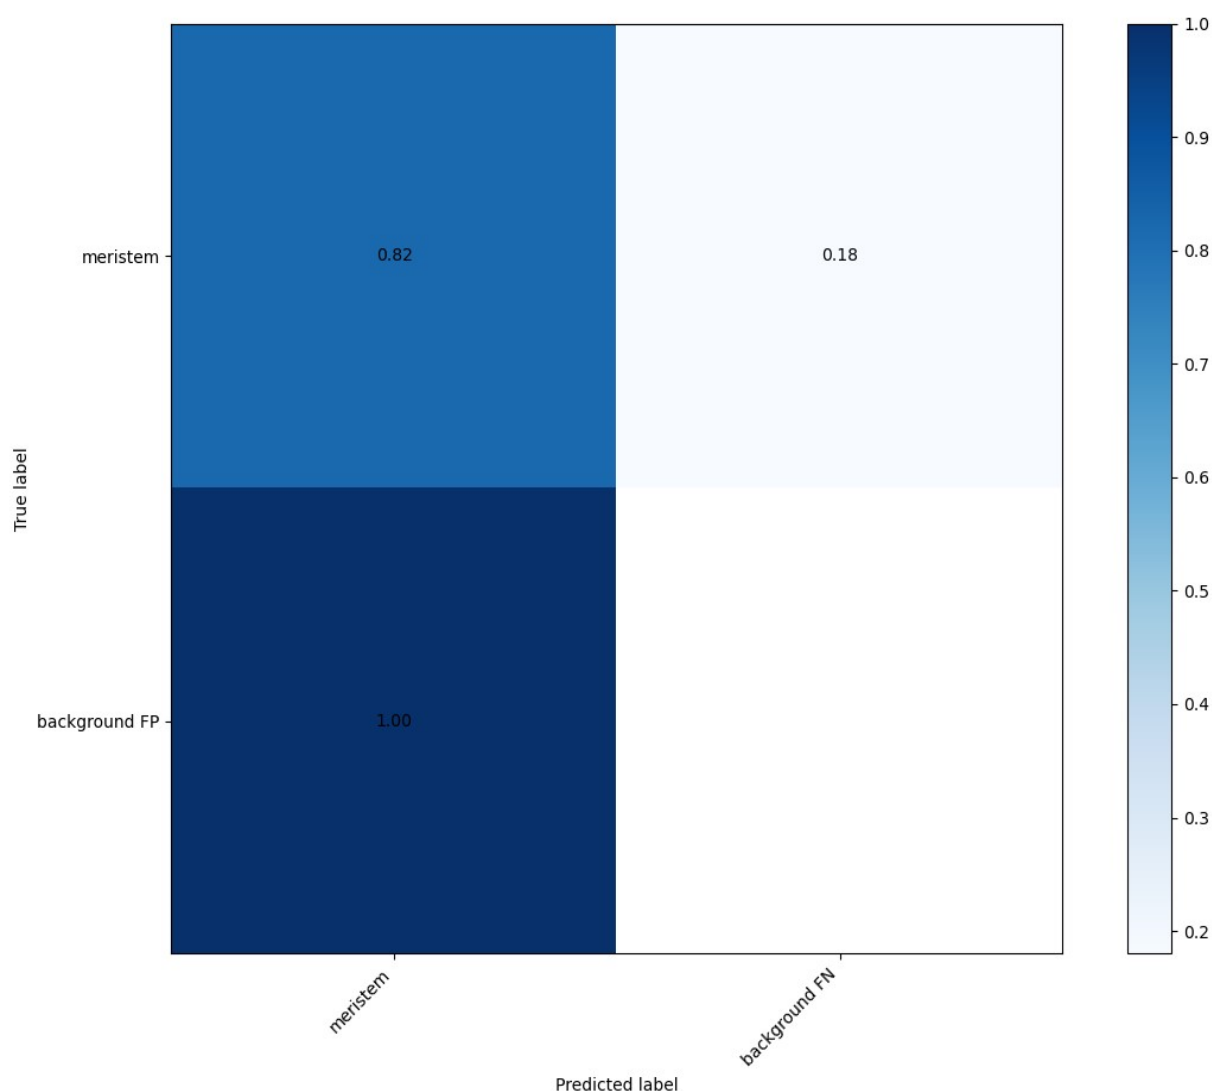
**Fig. 3.7. Confusion Matrix: Display of AI's classification accuracy in identifying meristems among other plant structures.**

According to the confusion matrix (Figure 3.7) the accuracy for meristem detection is 82% so the KPI is accomplished in this respect. The precision of the meristem localization is evaluated in the following section(s).

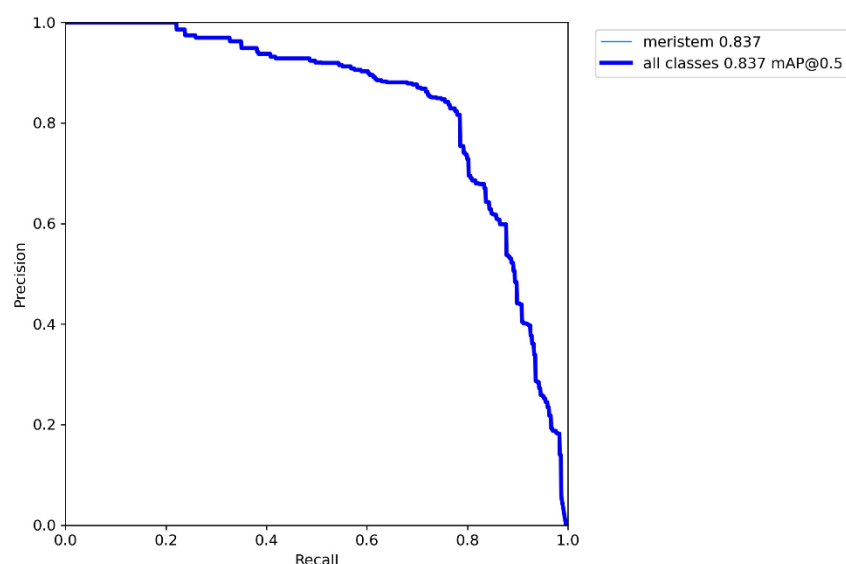
**Fig. 3.8. Precision-recall curve: The balance of precision and recall in AI's meristem detection.**

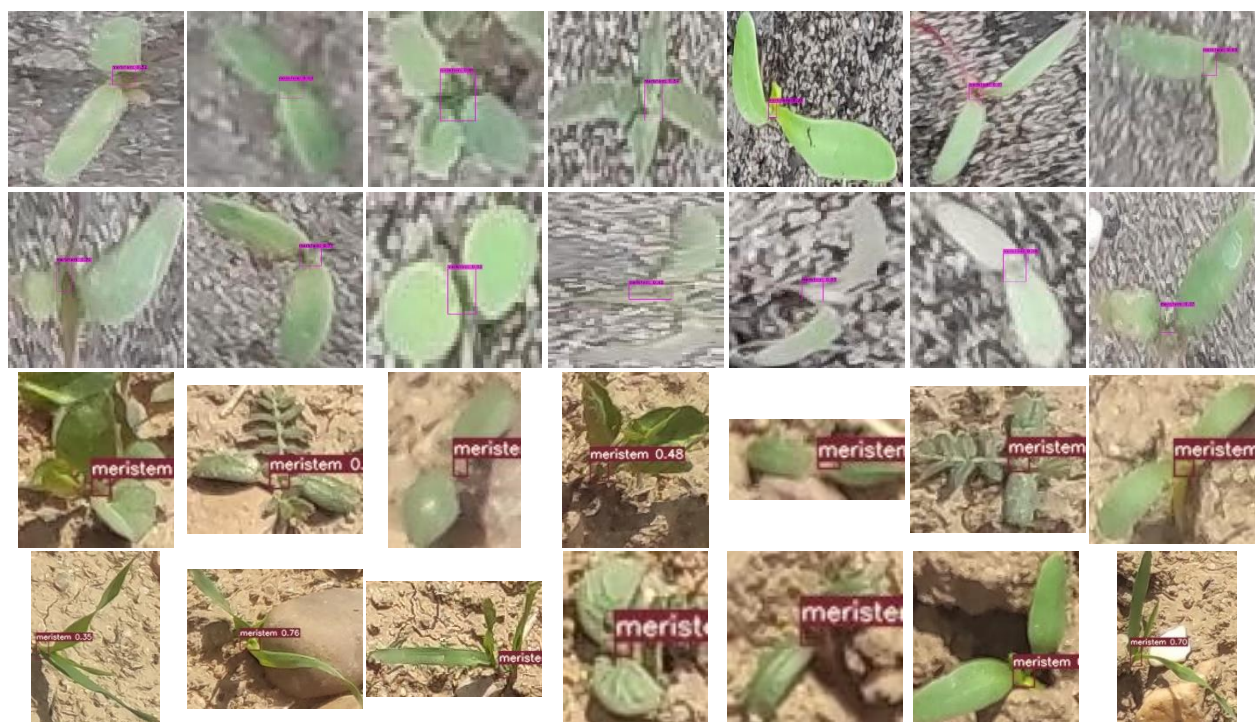
**Figure 3.9 Sample images: Demonstration of AI's meristem detection.**

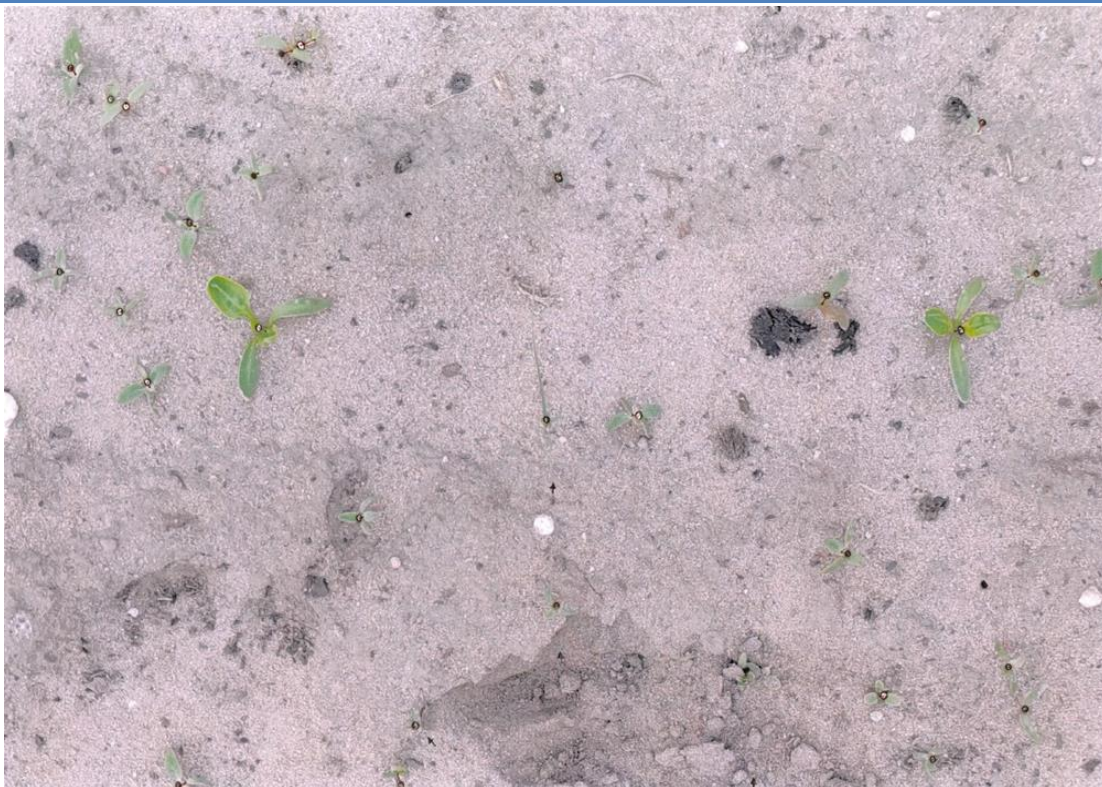
The primary results are captured in Figs. 3.10 and 3.11. These images visualize the effectiveness of the laser targeting. They show the laser shots on the printouts, indicating how accurately the laser, guided by AI, hit the targeted meristems. The variations in laser impact at different heights offer a clear insight into the precision and adaptability of our targeting system.

**Fig. 3.10. Printout images with visible shots: Demonstrating the precision of AI-guided laser shots on meristems at a height of 800 mm.**

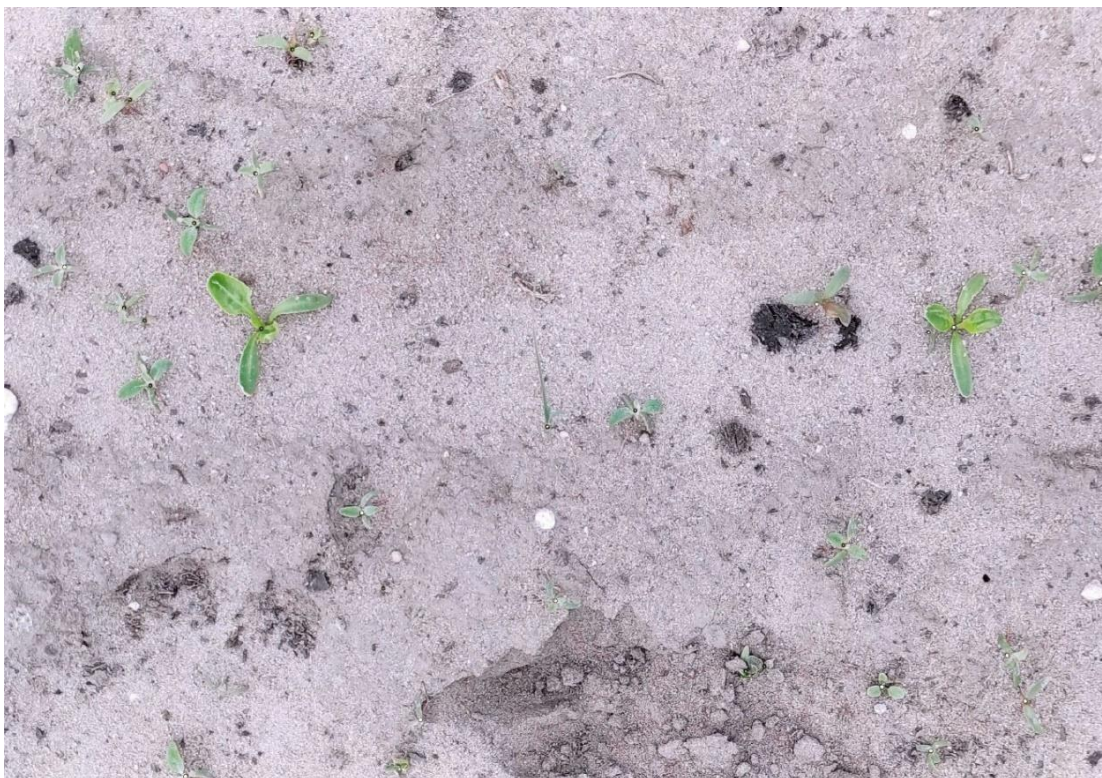
**Fig. 3.11. Printout images with visible shots: Demonstrating the precision of AI-guided laser shots on meristems at a height of 600 mm.**

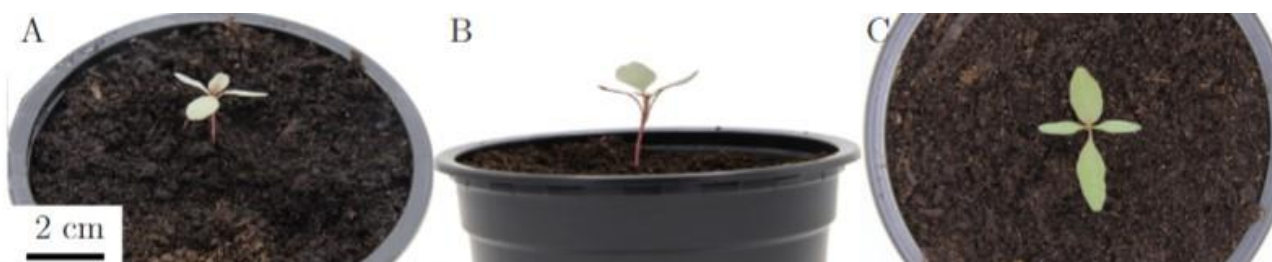
Initially, *Amaranthus retroflexus* (AMARE) sample plants were assessed at the BBCH12 growth stage to determine the optimum condition for laser treatment. These initial images, shown in Fig. 3.12, served as a baseline for subsequent evaluations of changes induced by laser treatment.

**Fig. 3.12. Condition of AMARE before laser treatment at BBCH12.**

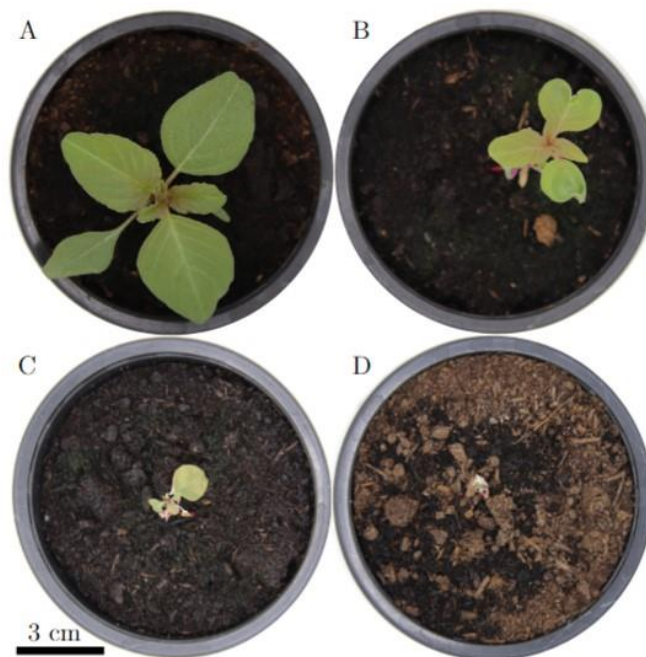
One week after the laser treatment, the plants were examined again to assess the immediate effects of the treatment. The results shown in Figure 3.13 were categorised into four groups to classify the immediate response to the treatment.

**Fig. 3.13. Condition of AMARE one week after different laser treatments. (A) untreated, (B) growth inhibited, (C) lethally damaged and (D) completely destroyed.**

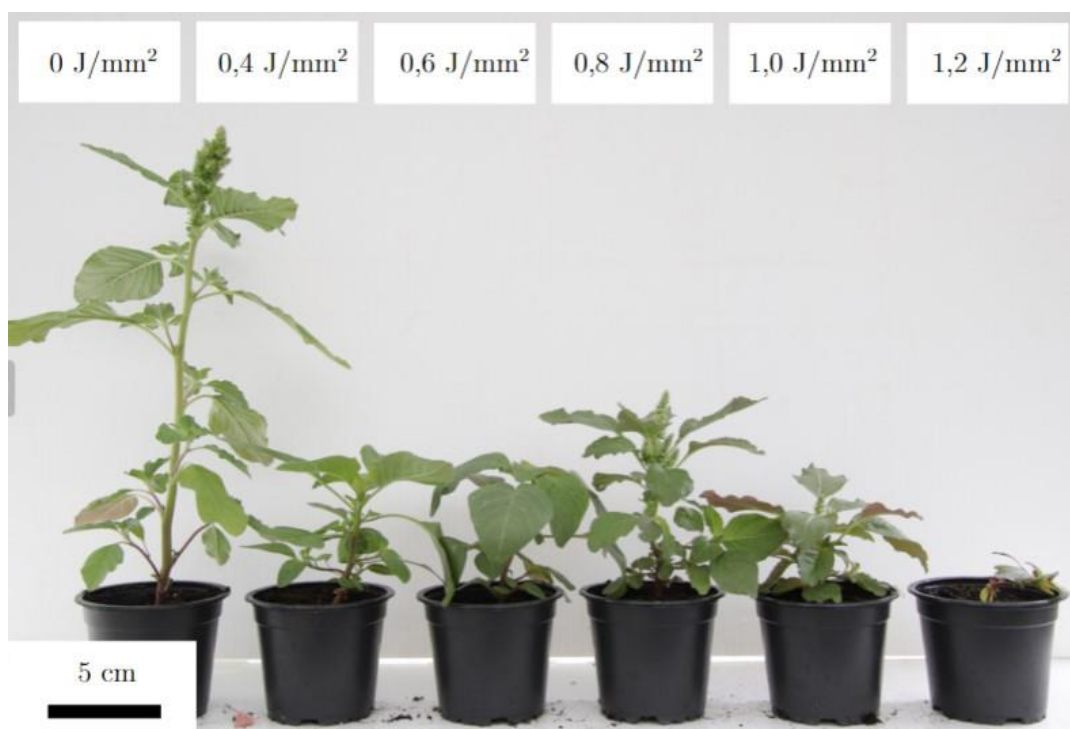
**Fig. 3.14. Four-week long-term effect of the laser treatment, depending on the dose applied. Doses above 1.0 J/mm² are showing a favourable effect.**

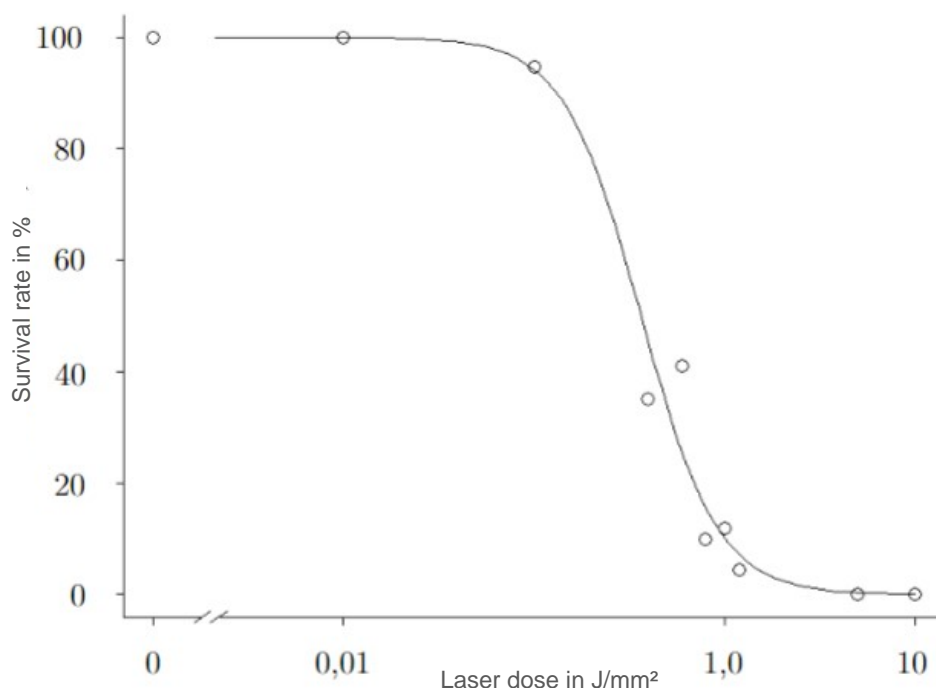
**Fig. 3.15. Graphical representation of the relationship between laser dose and plant response.**

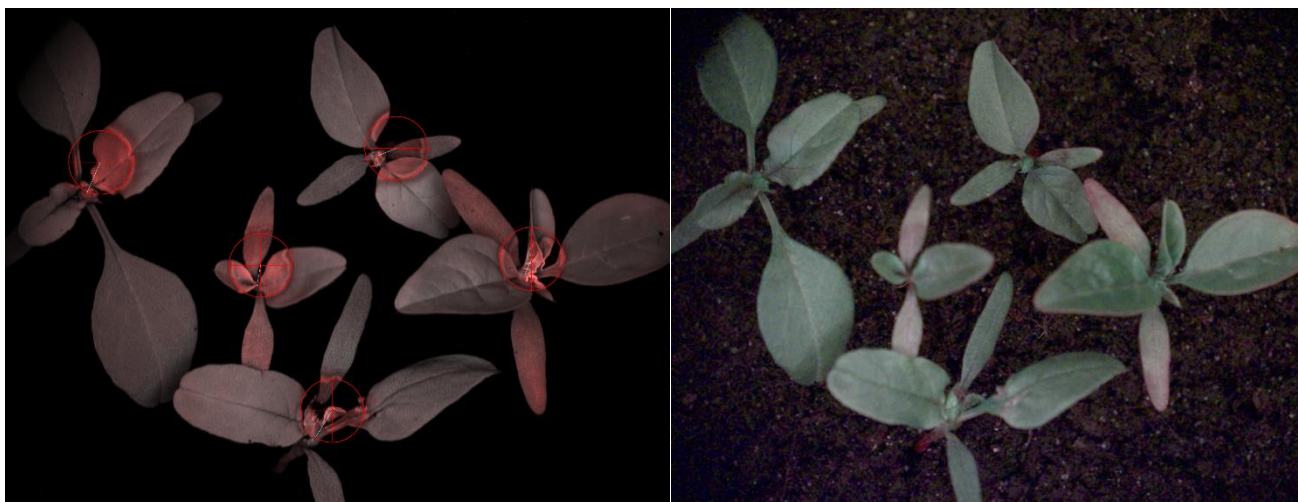
**Fig. 3.16. Comparison of CF and RGB images to demonstrate the impact points of the laser treatment. The section shown is directly under the laser scanner.**

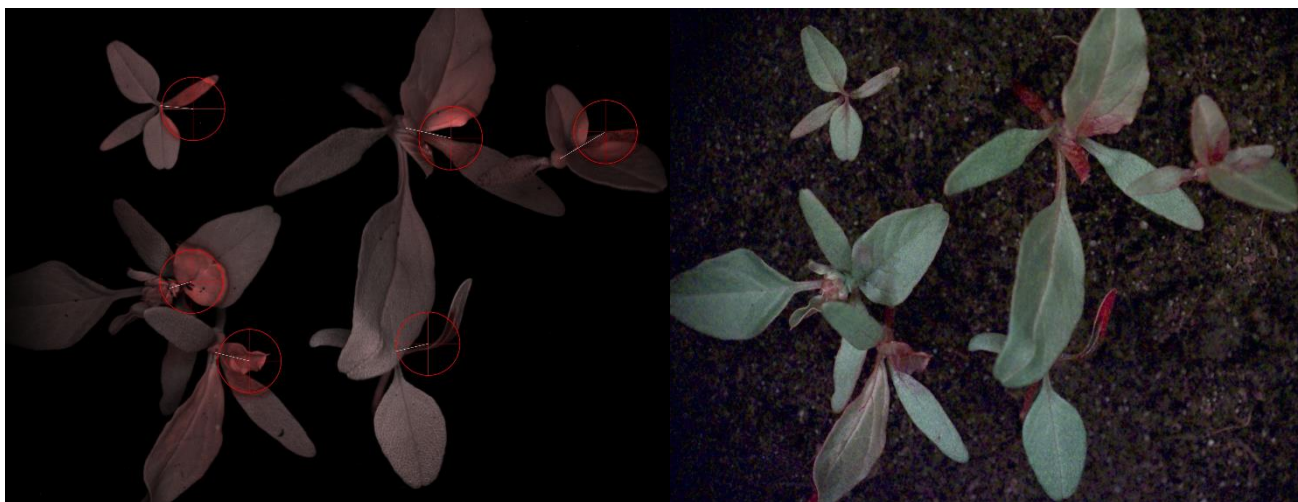
**Fig. 3.17. Comparison of CF and RGB images to demonstrate the impact points of the laser treatment. The section shown is in the corners of the scan field.**
