## **Sustainable Weed Management in Agriculture with Laser-Based Autonomous Tools**

### **D5.3 – Equipment integration, testing, evaluation, and impact on crops and soil**

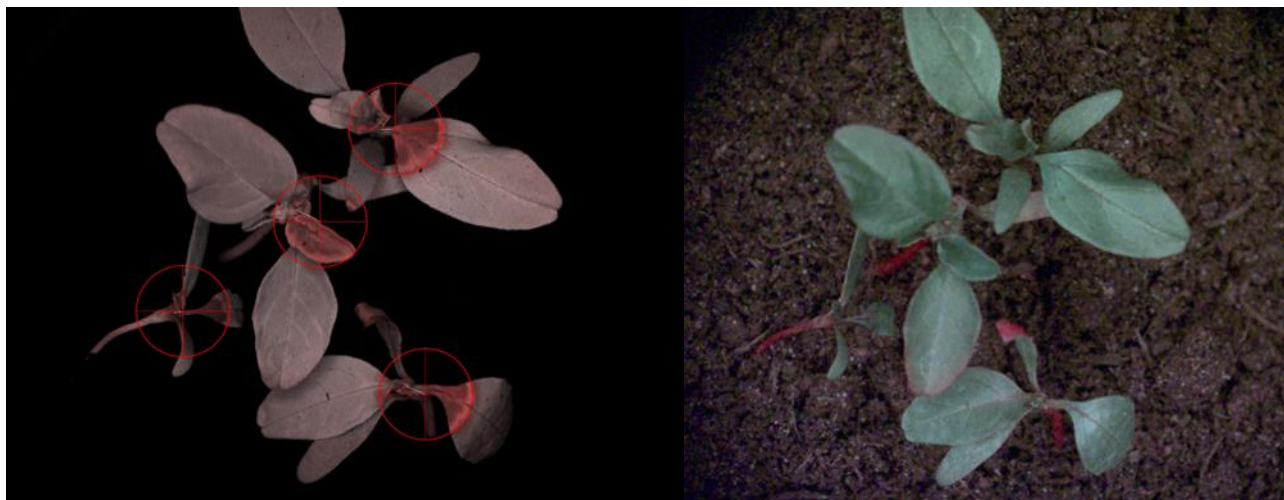
**Fig. 3.18. CF images after the introduction of the high-frequency beam movement, confirming the effectiveness of the treatment adjustment for challenging areas of the scan field. The movement is achieved by a circular trajectory of 2 mm from the target point.**

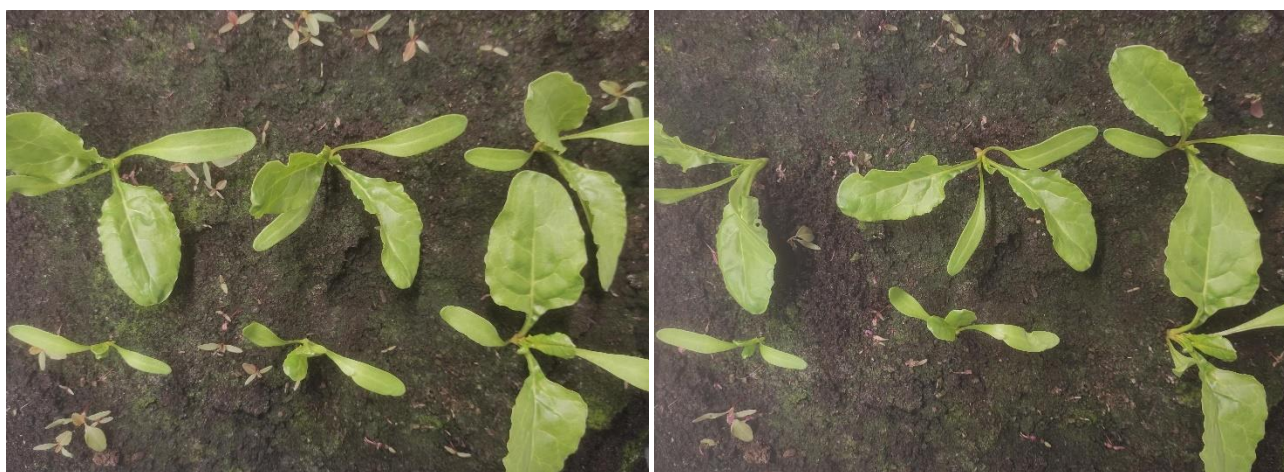
The before and after images in Fig. 3.19 show the effectiveness of the modified laser treatment. They show 38 AMARE plants between sugar beets in optimal growing conditions. Additional experiments were carried out with 54, 63, 81 and 23 weed plants. They confirm that all the targeted weeds were successfully killed.

**Fig. 3.19. Before and after comparison to demonstrate successful laser treatment. This sample was treated with a 200 ms irradiation time, 100 W laser power and 5.1 mm average beam diameter.**

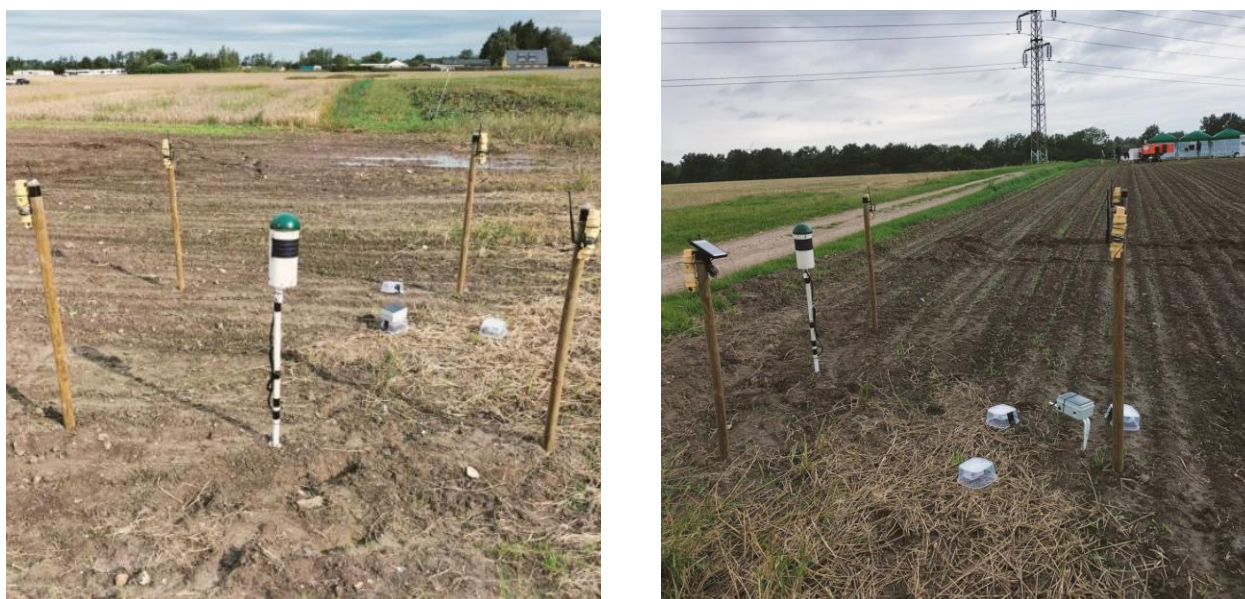
**Fig. 3.20. IoT devices at Taastrup demo field.**

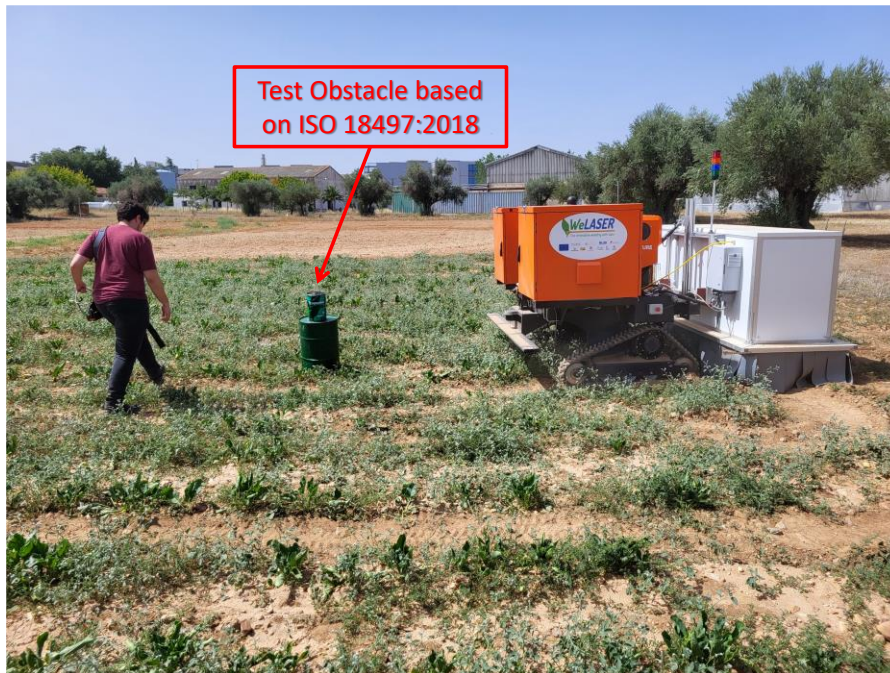
**Fig. 3.22. Image of the obstacle used for validation tests of the safety system.**

1. The implementation of several sensors with a range of 10 m is only possible through the implementation of at least 3 LIDAR systems, such as the one provided by the mobile platform at the front (see Fig. 3.22), and given the morphology of the robot and the weeding tool, this solution was not feasible to implement. Moreover, under operating conditions, the 10-meter radius is a very large area where obstacles can always be found, such as weeds, trees, workers, etc.

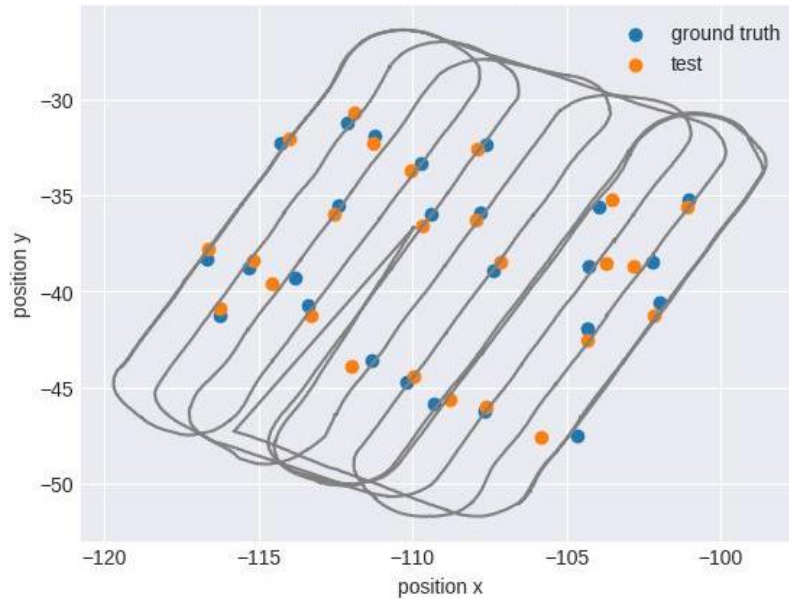
**Fig. 3.23.** Trajectory followed by the robot in the Section 2.3 (see Fig. 3.1.b) of the experimental fields at CSIC facilities, executing a treatment mission. In the blue locations, the test obstacle was placed following the standard ISO 18497:2018. The orange locations represent the estimated positions of the obstacle location according to the robot's safety system.

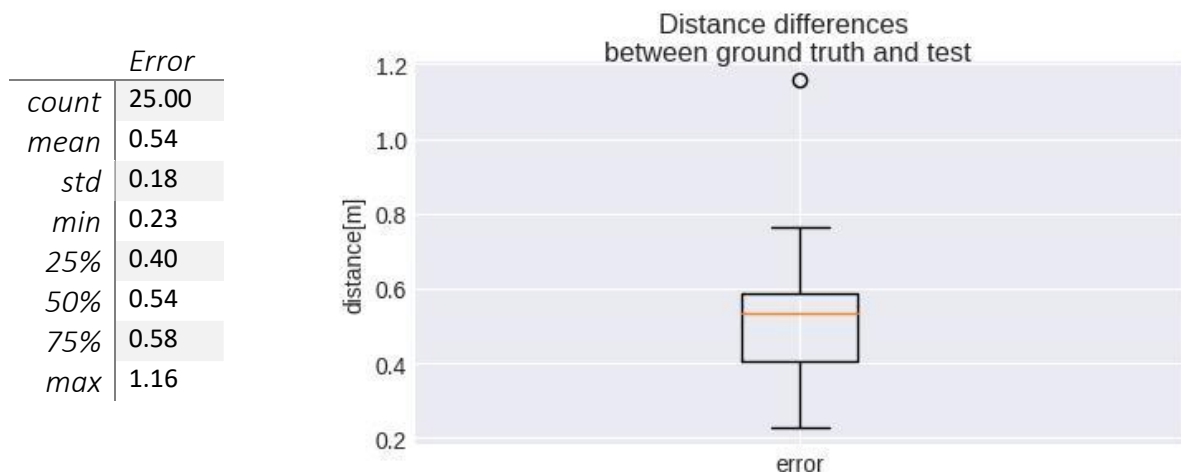
Figure 3.24 presents the statistical analysis of the estimation error of the obstacle position, where it should be noted that the radius of the obstacle is 0.38 m.

**Fig. 3.24. Statistical analysis of obstacle detection.**

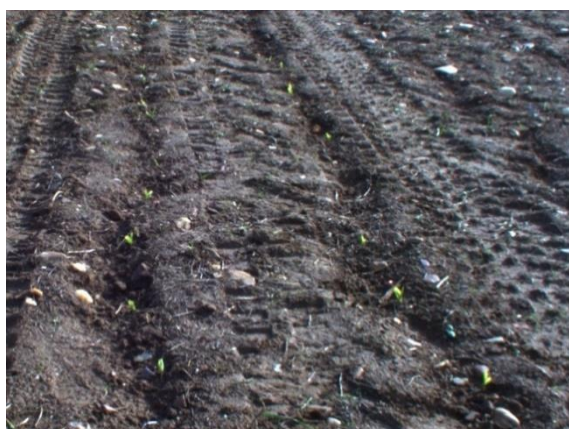
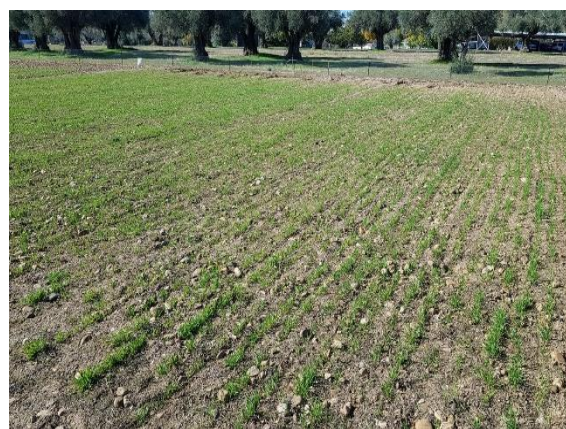
**Fig. 3.25. Example of (a) maize field, and (b) wheat field in the experimental fields at CSIC facilities at M13 (October 2021).**

the ability of this methodology to identify both wheat and maize was demonstrated, since they were the only two crops that could be planted out of season, between M13 – M14 (October - November 2021). Figure 3.25 presents two examples of the fields prepared during said period, both for maize (a) and wheat (b).

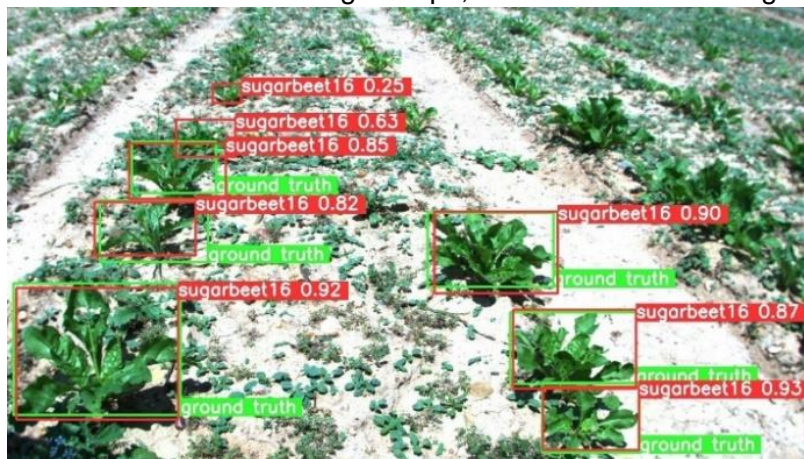
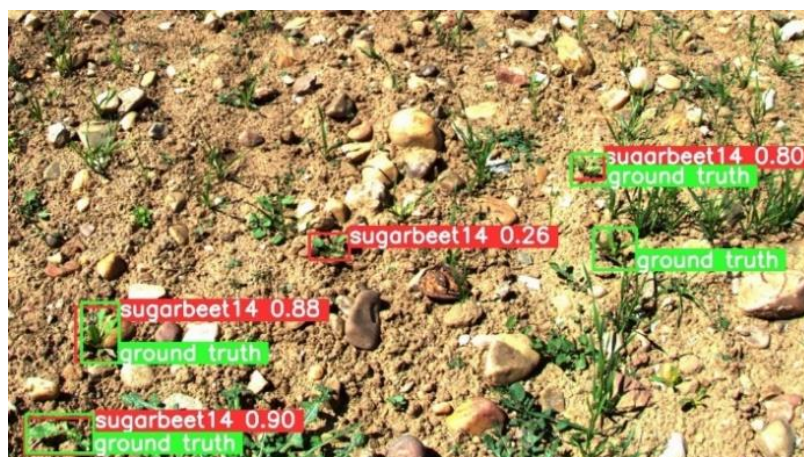
**Fig. 3.27. Detection (red) vs. ground truth (green) example. The model detections are highlighted in red, identifying the crop and confidence of the detection. The initial annotations for training are high-lighted in green. (a) Example of correct detections of sugar beet plants that were not initially labelled. (b) Example of a case of incorrect detection of weeds as sugar beet plants with a confidence of 0.26.**

Not only was a system implemented to detect the target crops of the WeLASER project, but also the said system was capable of identifying the growth status of each crop, focused particularly on maize and beets, given that throughout the development of the project, it was the two crops that were the focus of efforts. Table 3.8 presents the results of the detection of the different growth states for maize and sugar beet, following the BBCH phenological scale, and Fig. 3.27 presents an example of the detection of said crops.

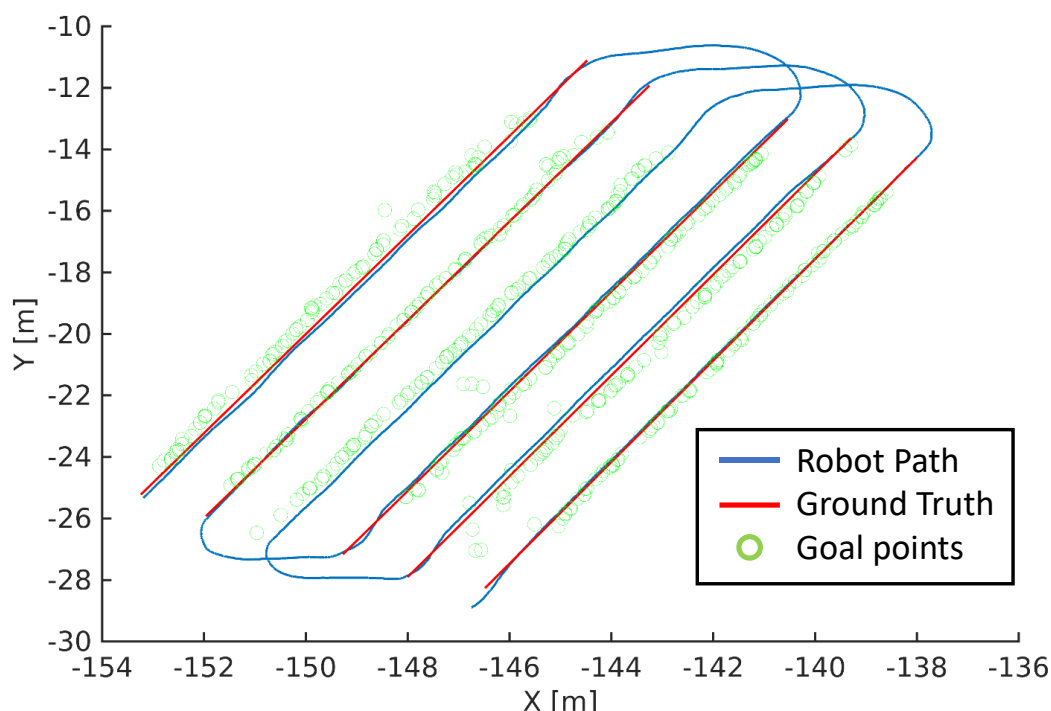
From the observed data, an outlier can be detected, which corresponds to line 2 of the Maize12 record. To appreciate in detail what happened, Fig. 3.28 presents the trajectory followed by the robot

**Fig. 3.28. Mission executed by the robot in the maize field with BBCH growth stage of 12, which includes: (i) Robot trajectory (blue), ground truth (red), target points generated by the guidance system (green).**

The first thing that stands out about this figure is that the ground truth cannot be observed in the central line, and hence the errors in line 2 for maize 12 in Table 3.10 are very large. To have a greater explanation of what happened, Fig. 3.29 presents the estimation of states of the guidance system, where it identifies when the robot enters a line (Lane) and when it leaves, i.e. when it reaches the headlands.

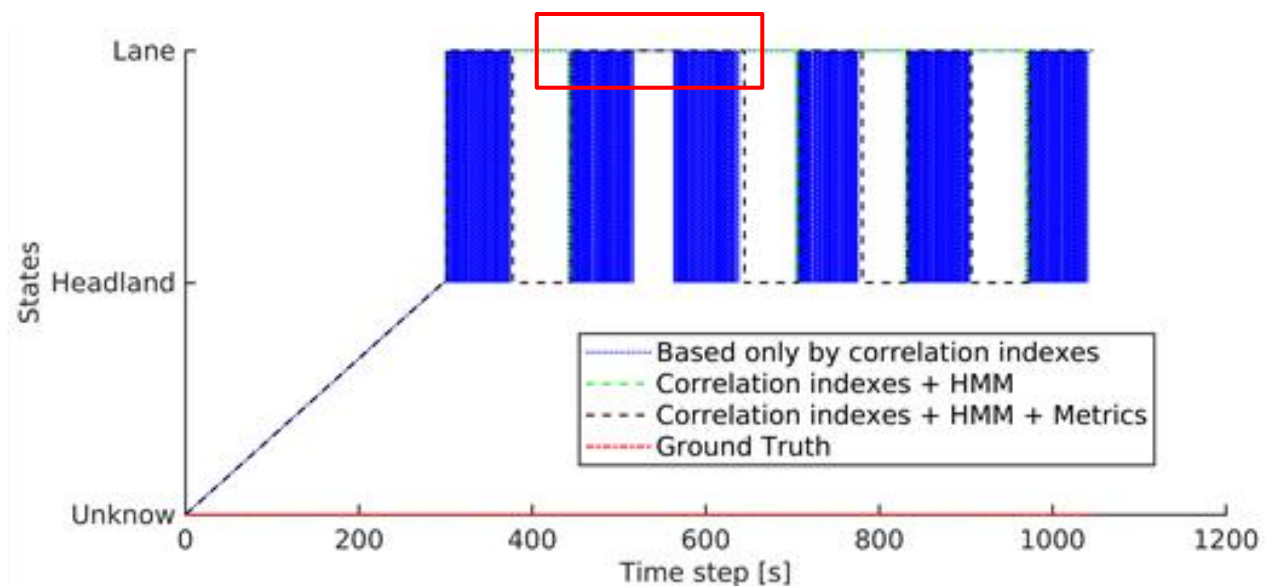
**Fig. 3.29. Estimation of states of the robot's localization in the field, while executing a mission in the maize field with BBCH growth stage of 12.**

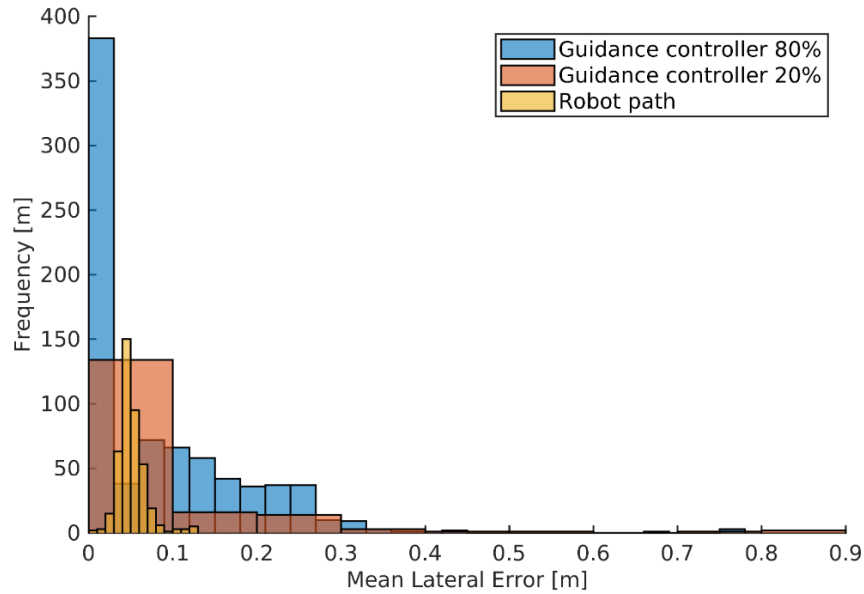
**Fig. 3.30. Histogram of the mean lateral error of the row guidance system compared with the robot error in following the path. The row guidance systems histogram is divided in the first 20% of the trajectory, and the 80% remaining.**

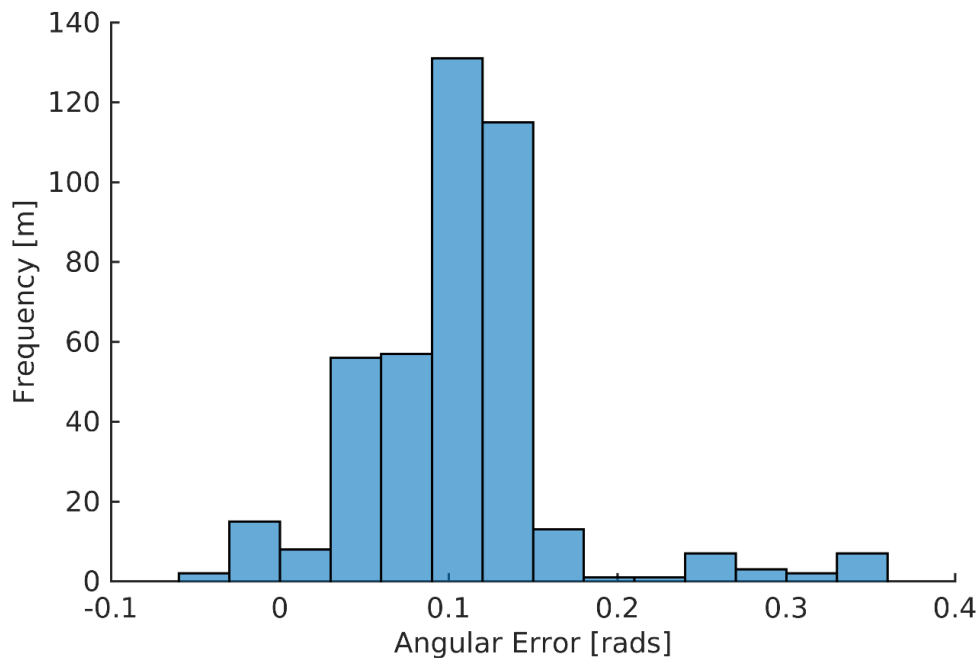
**Fig. 3.31. Histogram of the mean angular error of the robot in following the straight path of the mission in the maize field with BBCH growth stage of 12.**

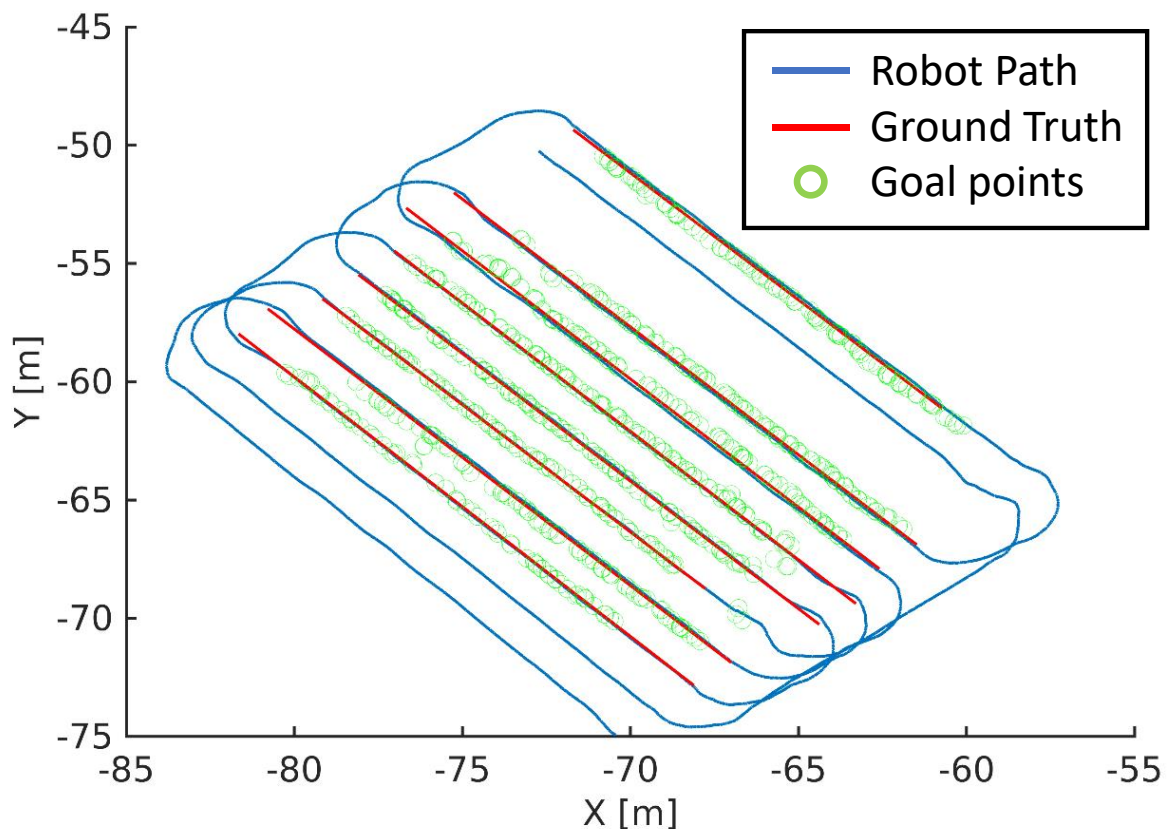
In this record it can be observed that the robot has satisfactorily followed the majority of the crop lines, with 3 remaining to be identified. Regarding these lines that were not identified, this has occurred because many maize plants were missing. This is mainly due to the time when the maize was planted, which did not correspond to the preferred dates for this type of crop. Fig. 3.34 presents a deeper insight into the detection of state change.

**Fig. 3.33. Mission executed by the robot in the maize field with BBCH growth stage of 14, which includes: (i) Robot trajectory (blue), ground truth (red), target points generated by the guidance system (green).**

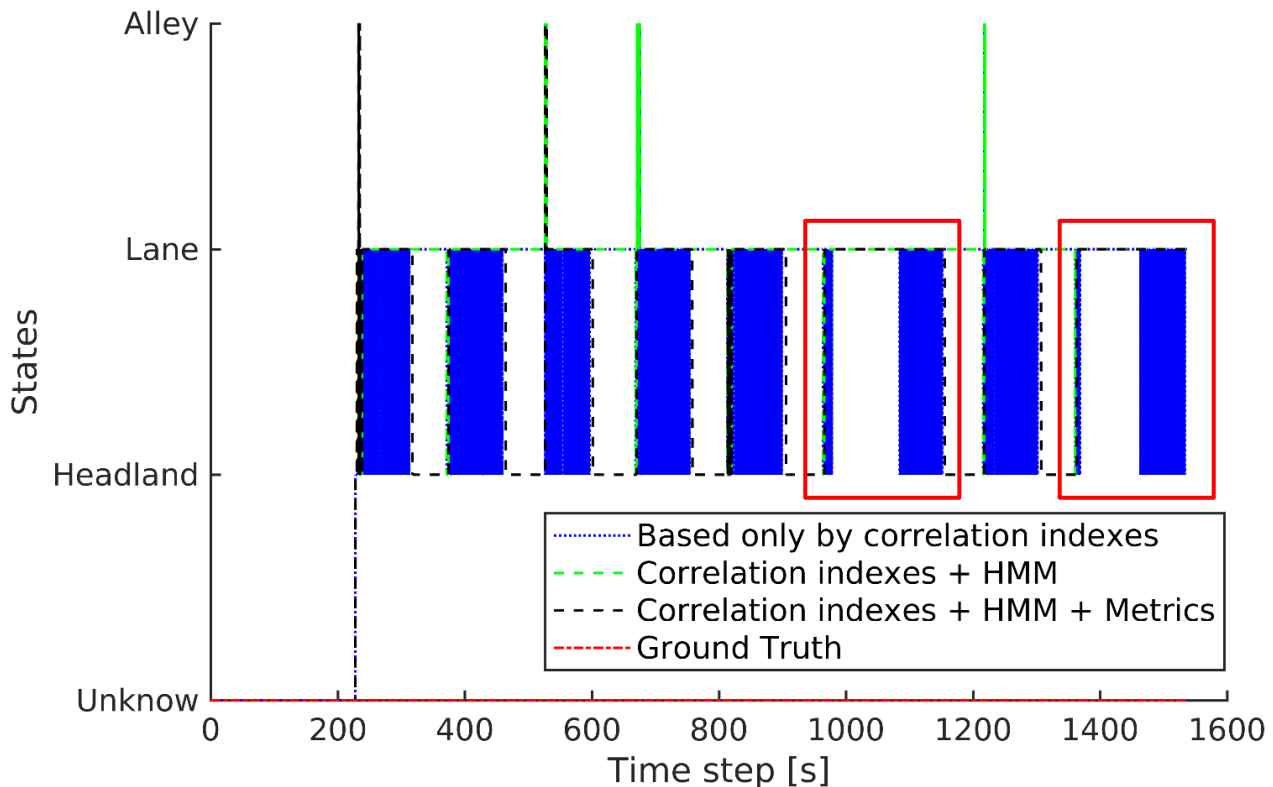
It can be observed in Fig. 3.34 that in lines 9 and 11 the system detects a change of state, from the Headland to the Lane. But shortly after, there is no longer a detection, i.e. no more estimation (see blue lines). This is due to the lack of information coming from the vision system. The same situation happens at the beginning of the mission, where the system is in an unknown state, also due to the lack of information.

**Fig. 3.34. Estimation of states of the robot's localization in the field, while executing a mission in the maize field with BBCH growth stage of 14.**

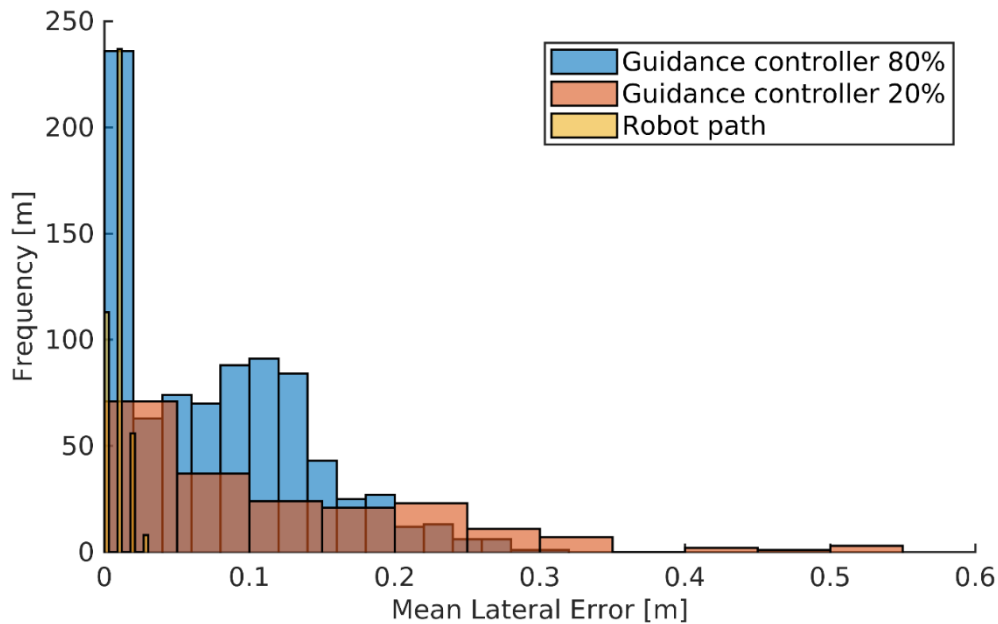
**Fig. 3.35. Histogram of the mean lateral error of the row guidance system compared with the robot error in following the path. The row guidance systems histogram is divided in the first 20% of the trajectory, and the 80% remaining.**

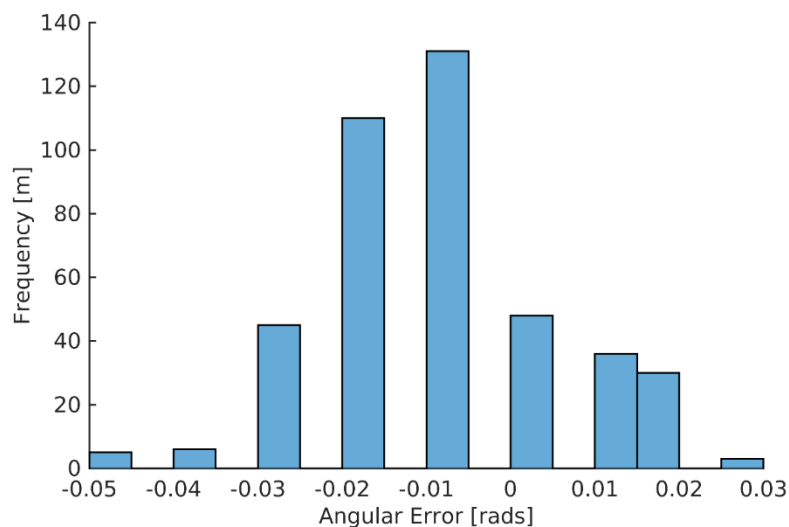
**Fig. 3.36. Histogram of the mean angular error of the robot in following the straight path of the mission in the maize field with BBCH growth stage of 14.**

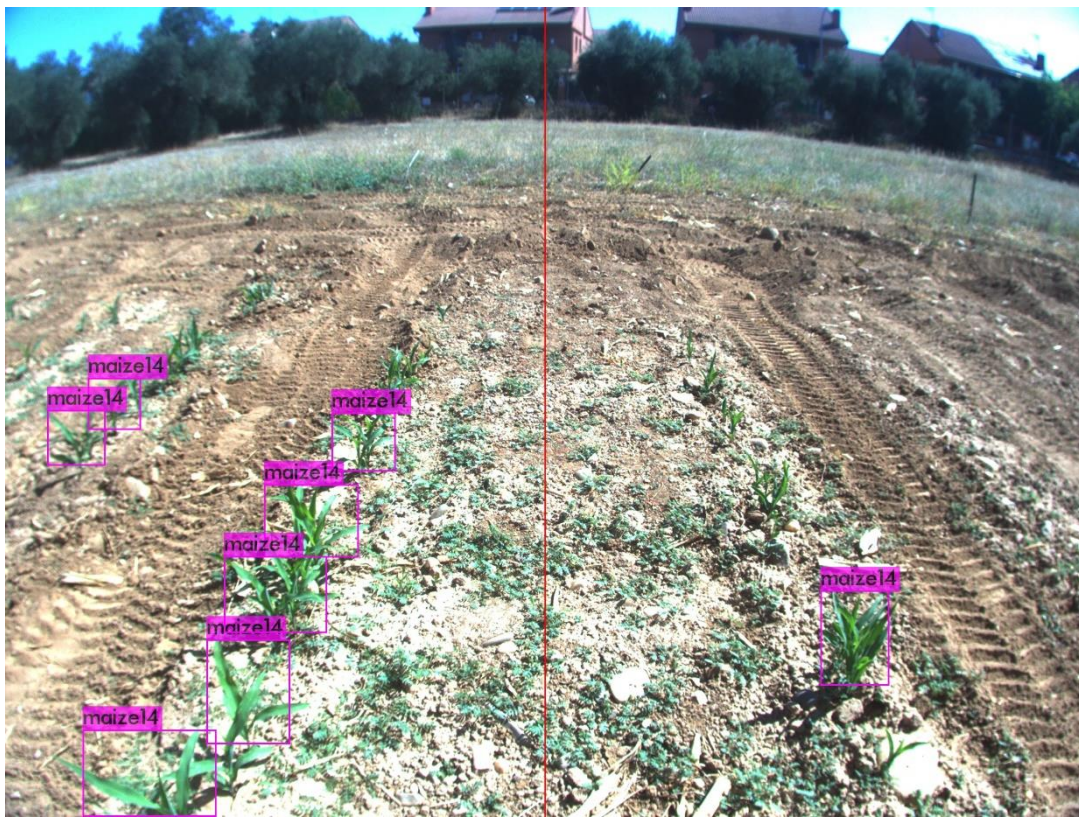
(a)

Figure 3.37 visually demonstrates the identification of the crop in this record and showcases the process of detecting crop lines and estimating goal points for their monitoring. The crop rows are detected through a clustering method applied to the points indicating crop positions, visible in the figure as red and green clusters. Additionally, the yellow and grey vectors represent the goal points, outlining the trajectory adjustments necessary for the robot to align with the crop rows.

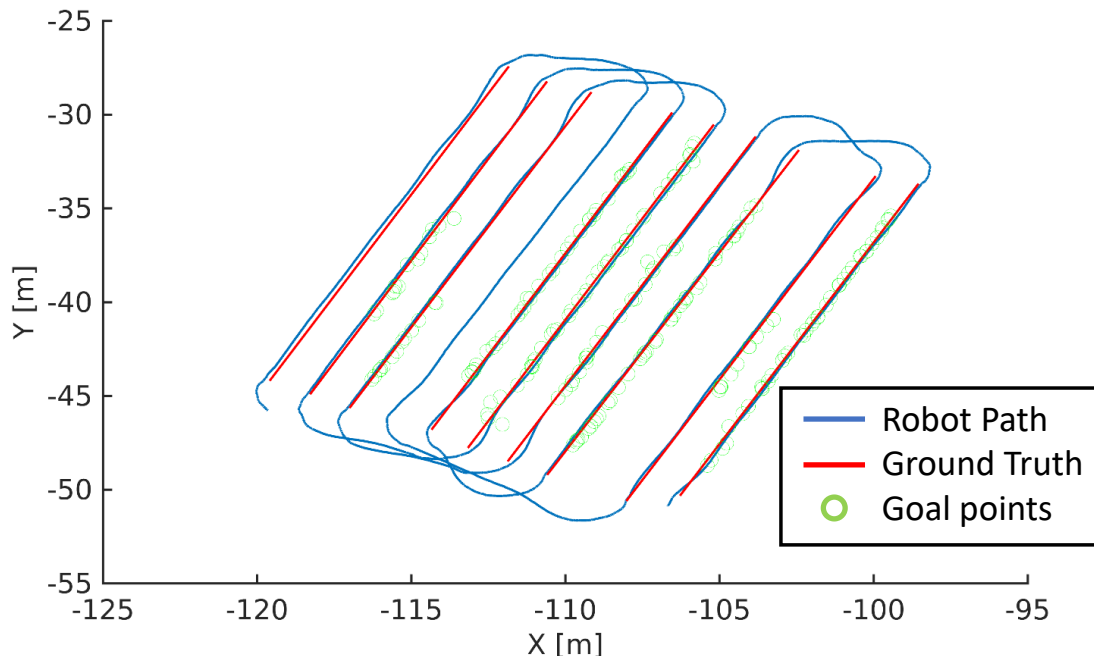
**Fig. 3.38. Mission executed by the robot in the sugar beet field with BBCH growth stage of 14, which includes: (i) Robot trajectory (blue), ground truth (red), target points generated by the guidance system (green).**

This record shows the robot's successful tracking of most crop lines, with only two remaining unidentified. This situation is similar to the one presented above, primarily caused by missing sugar beet plants due to the planting timing not aligning with the optimal schedule for this crop type. Moreover, Fig. 3.39 provides a more detailed examination of the state change detection.

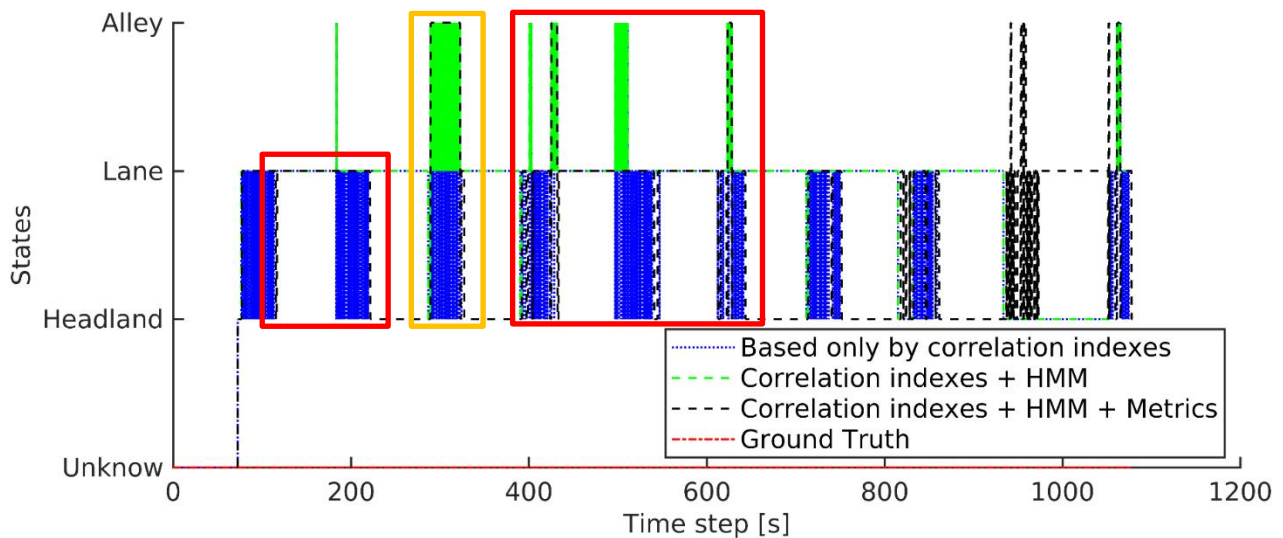
It can be observed in Fig. 3.39 that there is a systematic failure to adequately detect changes in state (see red boxes in Fig. 3.39), or a change from Lane to Headland is detected but it returns to the Lane again. This is a failure in the guidance system estimation of the chase of the goal points, and requires further development to mitigate these failures. Moreover, it is also possible to observed that in several cases an alley detection is carried out (especially in yellow box in Fig. 3.39). This is because only one of the crop rows is detected, or there is only the presence of crops in one of them.

**Fig. 3.39. Estimation of states of the robot's localization in the field, while executing a mission in the sugar beet field with BBCH growth stage of 14.**

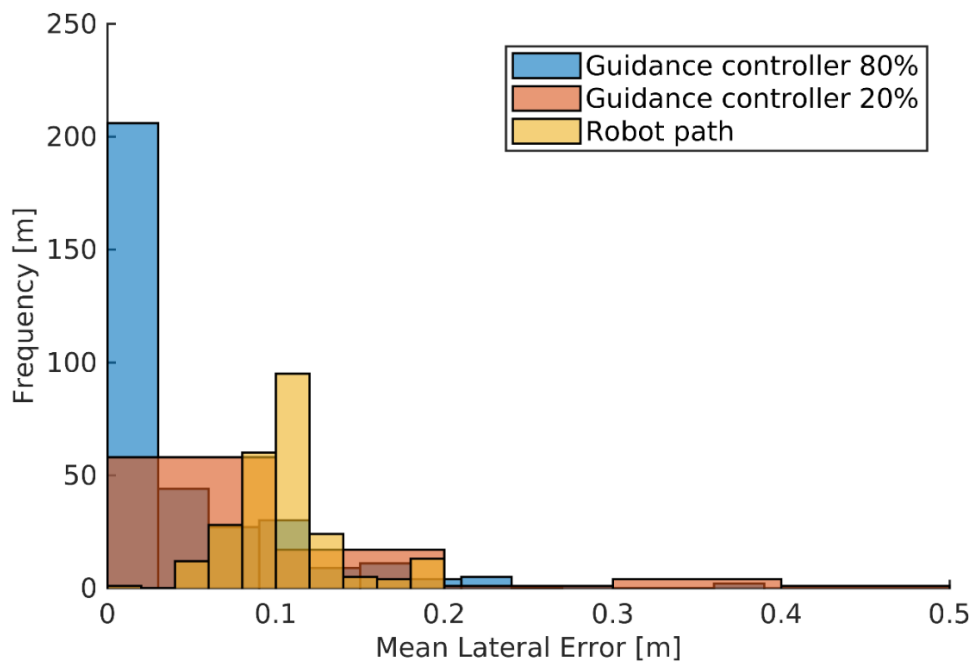
Regarding the in-depth statistical examination, Fig. 3.40 presents a histogram contrasting the average error values between the robot's lateral error and the crop guidance system. The analysis reveals that, for 80% of the trajectory, the crop guidance system presents a smaller lateral error than the robot guidance, confirming the value of the crop guidance system on improving robot guidance in crops. Greater advances are required to be able to develop a more robust crop guidance system, which adapts to the real conditions of the field, where in many cases the crops are missing or are occluded by weeds.

**Fig. 3.40. Histogram of the mean lateral error of the row guidance system compared with the robot error in following the path. The row guidance systems histogram is divided in the first 20% of the trajectory, and the 80% remaining.**

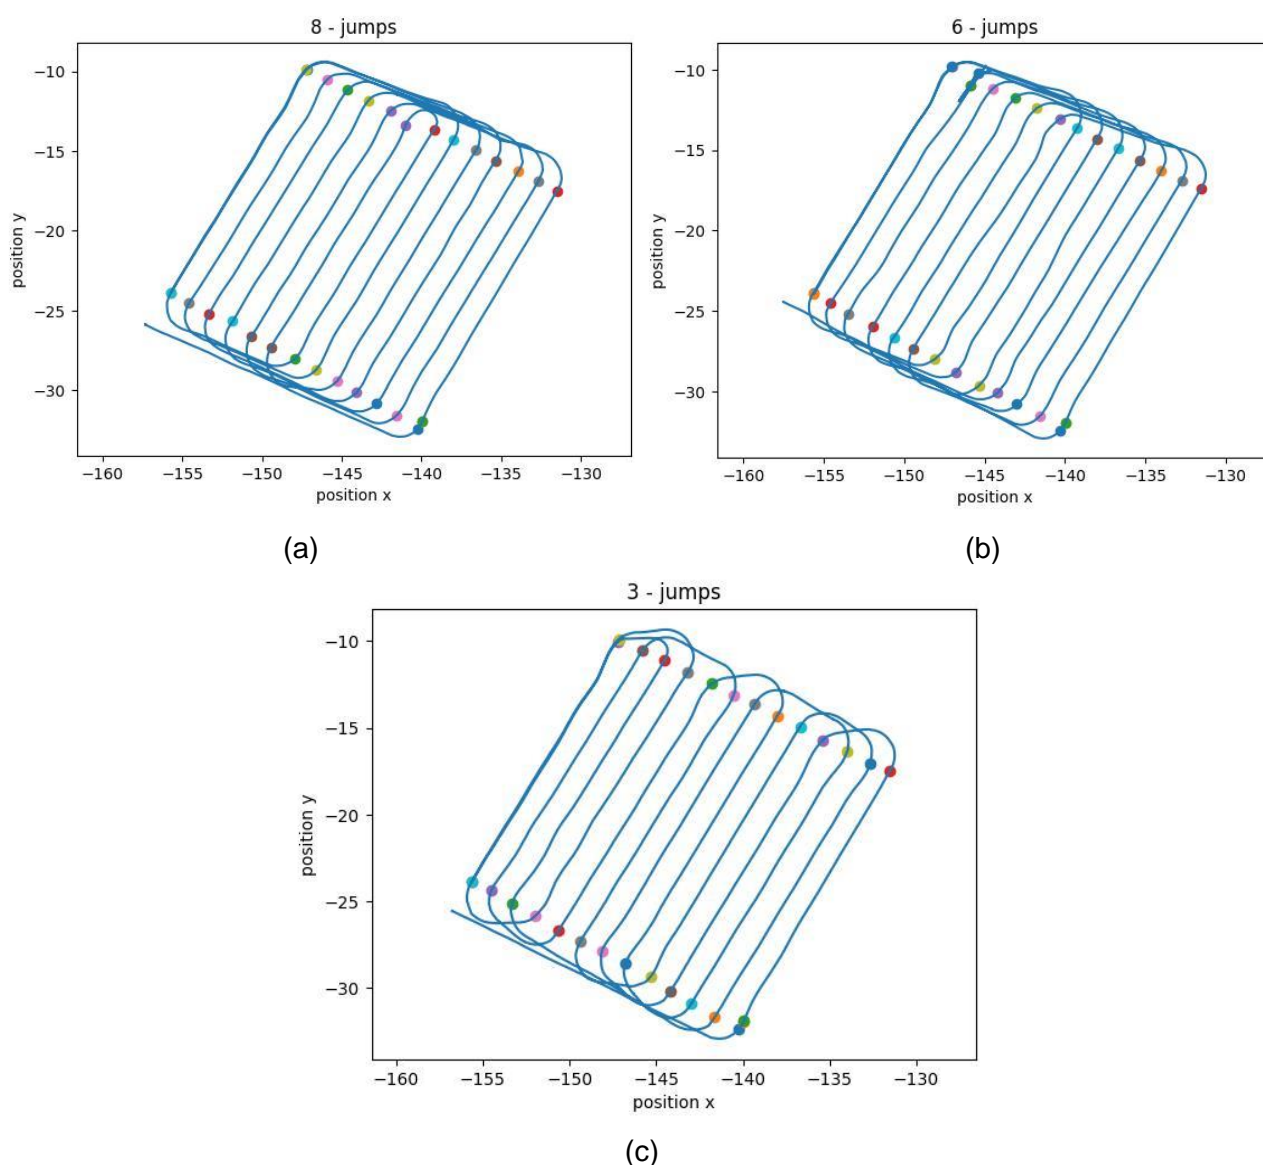
For this study, 3 missions were carried out in the same field, with different jump parameters: 3, 6 and 8. It should be noted that given the characteristics of the field and that the planner is a system that seeks the optimal trajectories in terms of distance travelled, the robot does not execute the desired jumps in all situations. Table 3.11 presents the results of the tests carried out, making it clear that the optimal configuration of 3 jumps prevails as the most appropriate option for this robot.

**Fig. 3.42. Trajectories performed by the autonomous robot in Section 2.1 (see Fig. 3.1.b) of the experimental fields at CSIC facilities, executing a treatment mission with different configuration parameters: (a) 8 jumps; (b) 6 jumps; and (c) 3 jumps.**

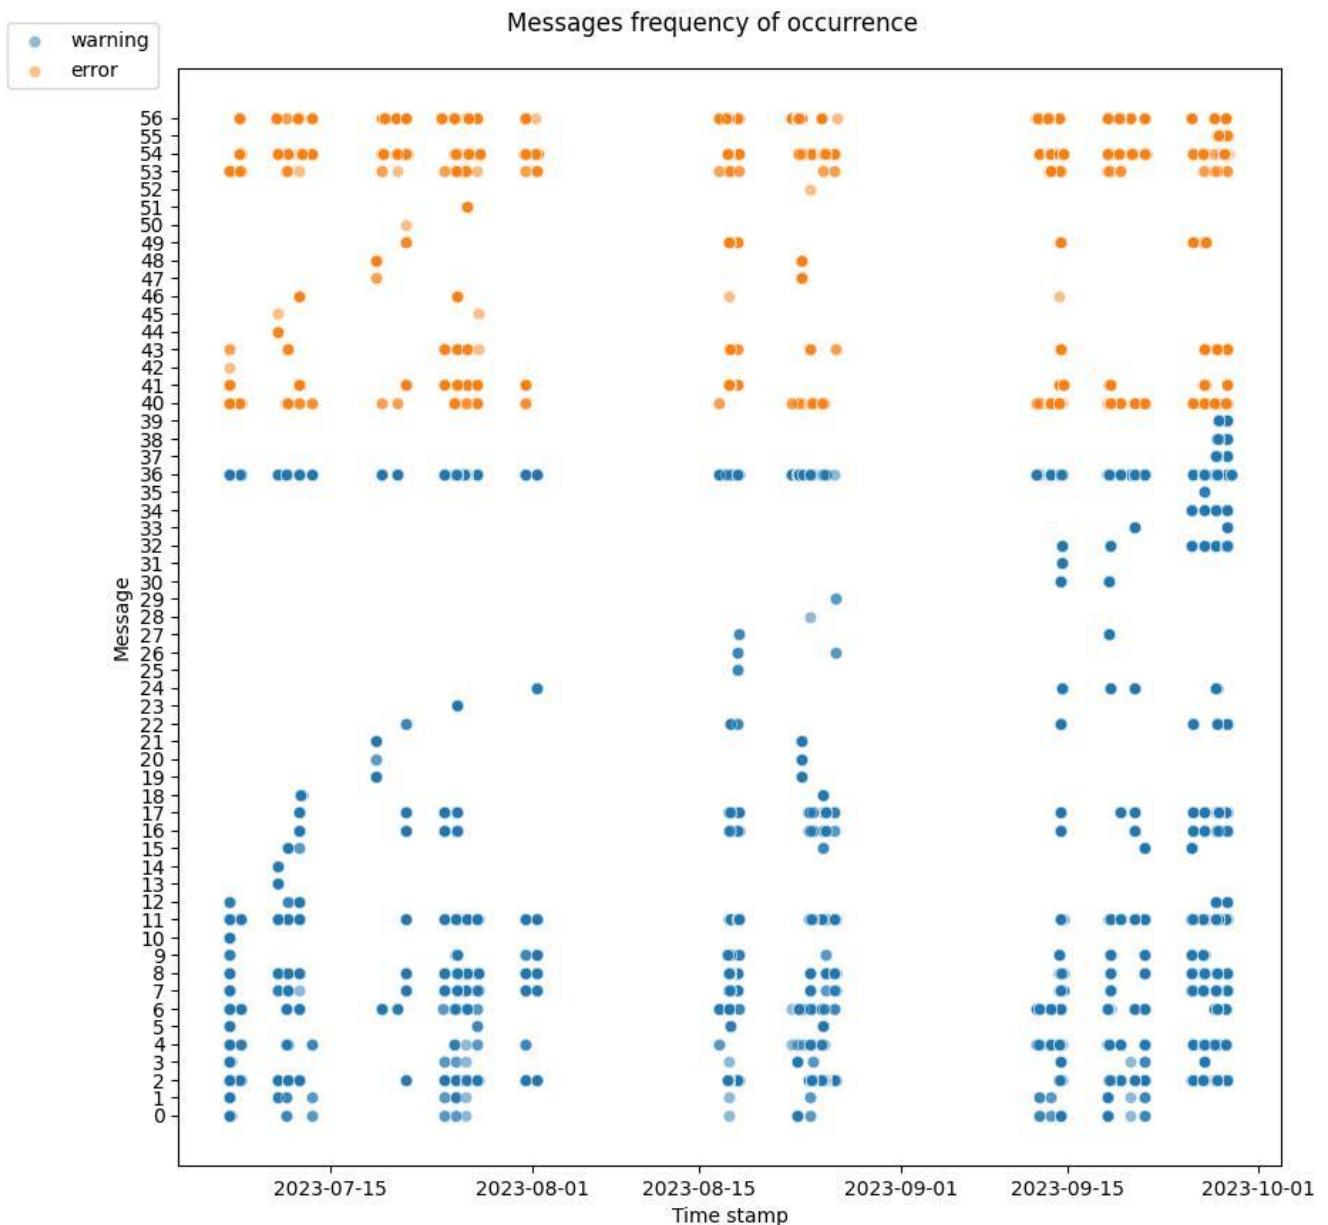
**Fig. 3.43. Distribution of the different malfunctions in the period of time under study, where each malfunction is represented by its identifier presented in the Table 3.12.**

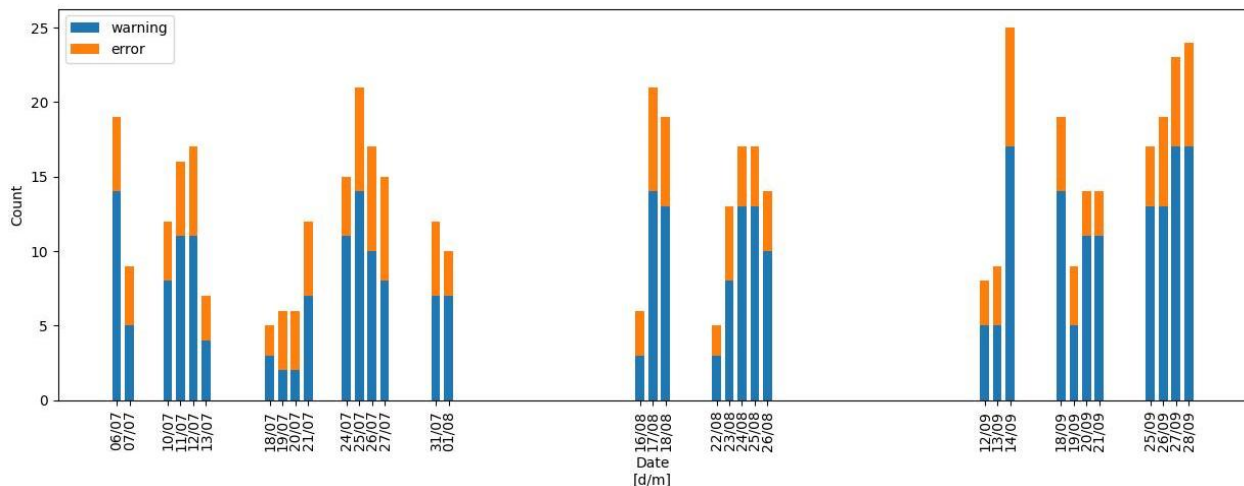
**Fig. 3.44. Distribution of unique malfunctions detected per day**

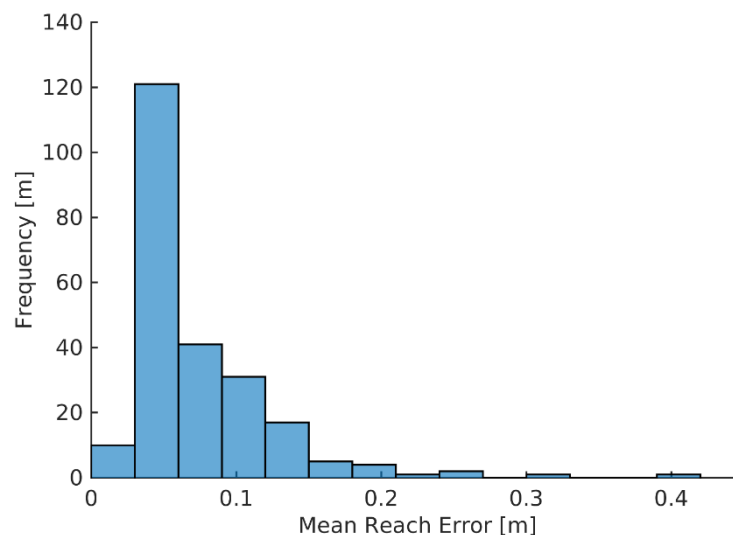
**Fig. 3.45. Histogram of the reach error of the lateral controller**

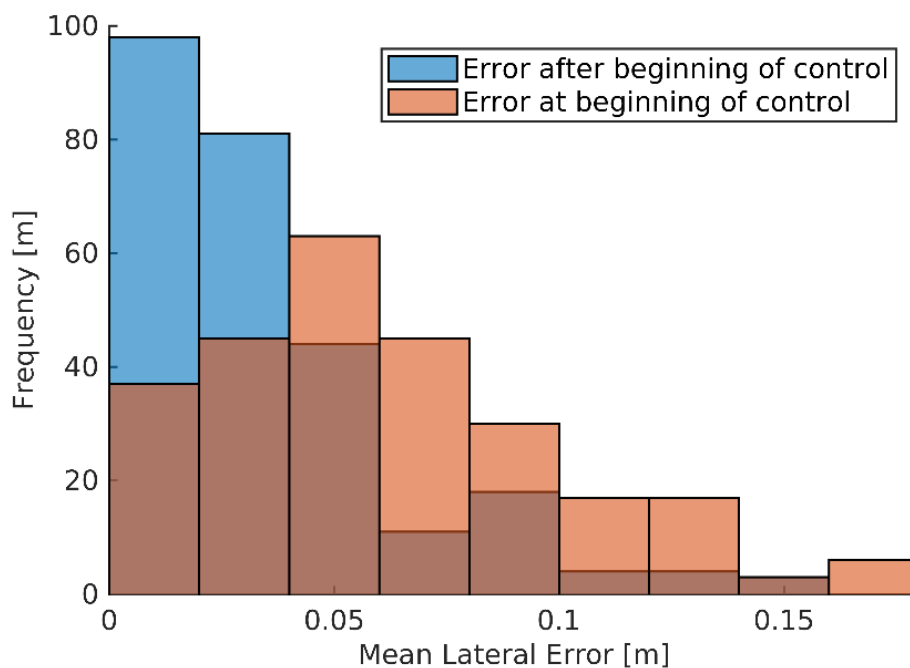
**Fig. 3.46. Histogram of the lateral error of the lateral controller**

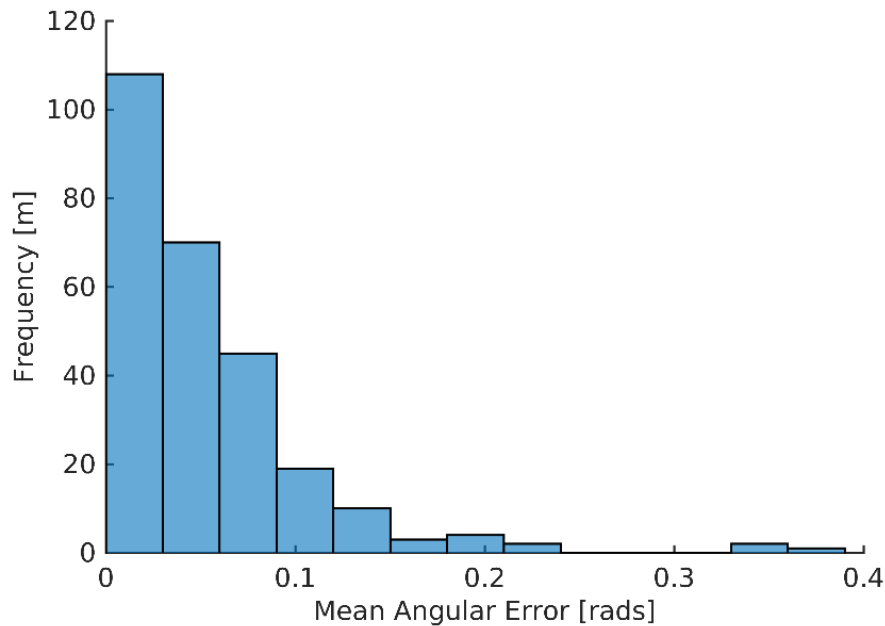
**Fig. 3.47. Histogram of the angular error of the lateral controller**

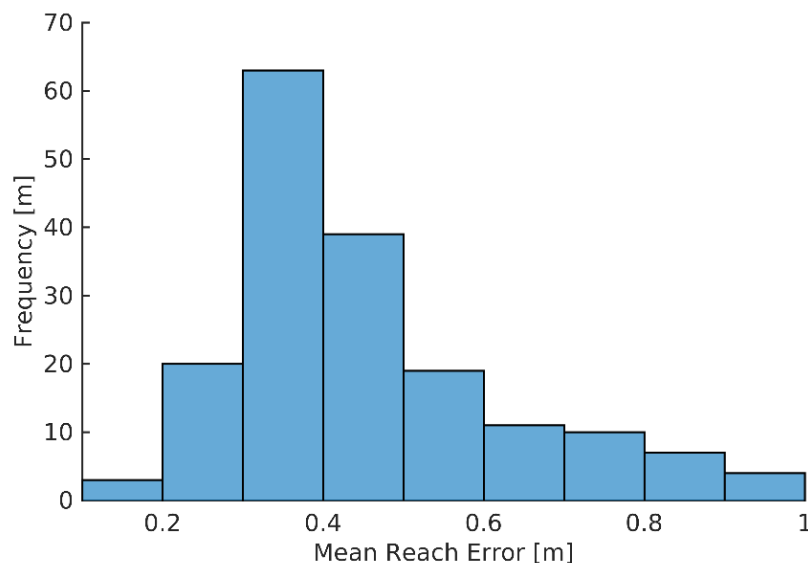
**Fig. 3.48. Histogram of the reach error of the spiral controller**

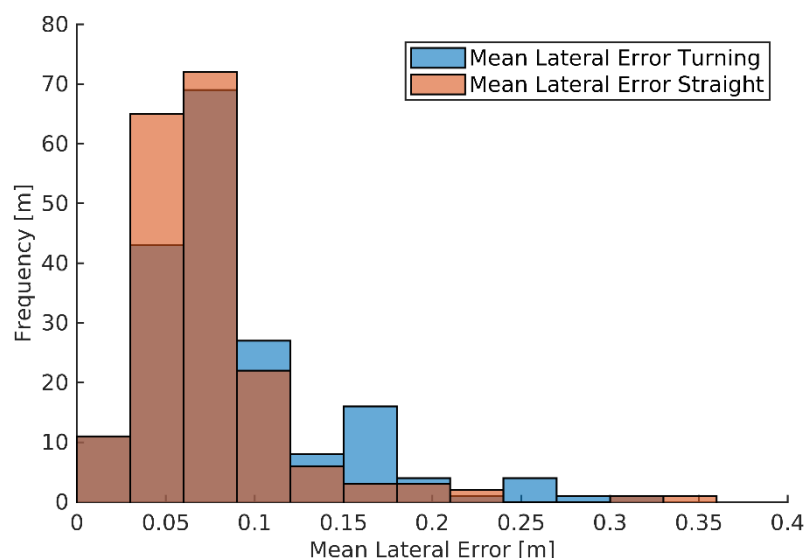
**Fig. 3.49. Histogram of the lateral error executing a GoToGoal trajectory**
