## **Sustainable Weed Management in Agriculture with Laser-Based Autonomous Tools**

### **D5.3 – Equipment integration, testing, evaluation, and impact on crops and soil**

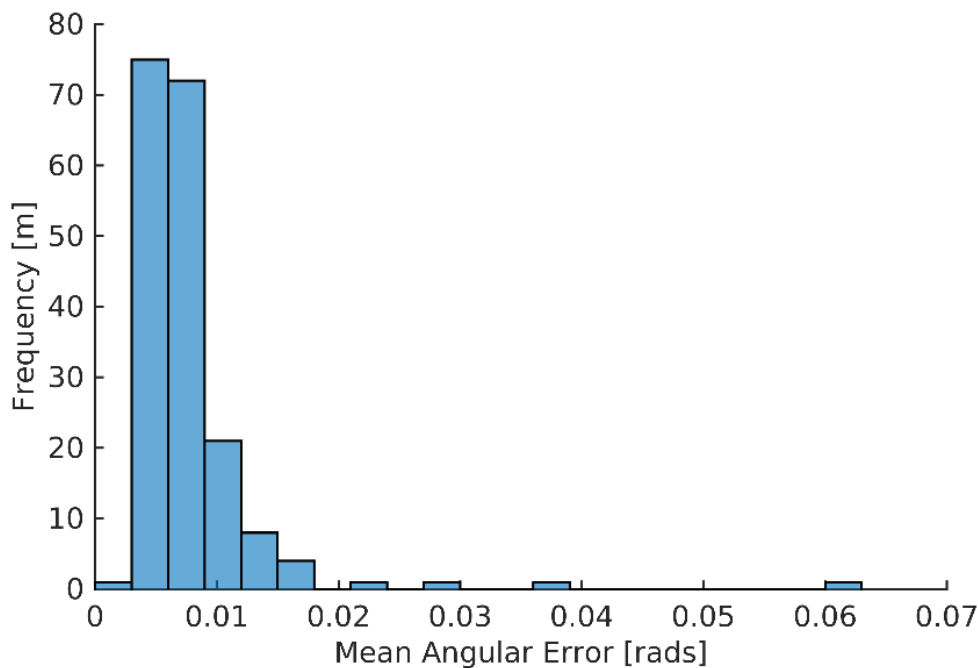
**Fig. 3.50. Histogram of the angular error of the spiral controller**

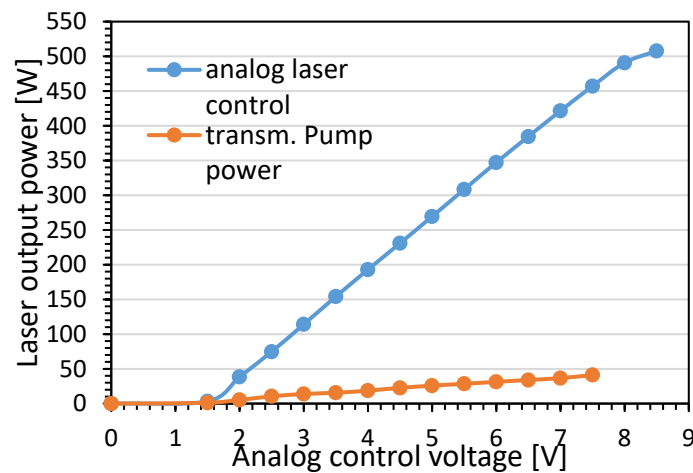
**Fig. 3.51. Output curve of the 500 W laser system using analogue control.**

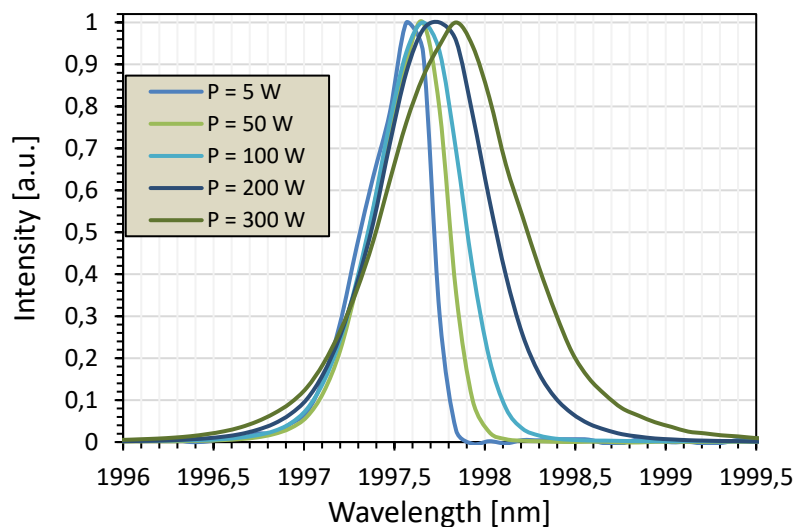
**Fig. 3.52. Emission spectra of the 500 W laser system at different output powers.**

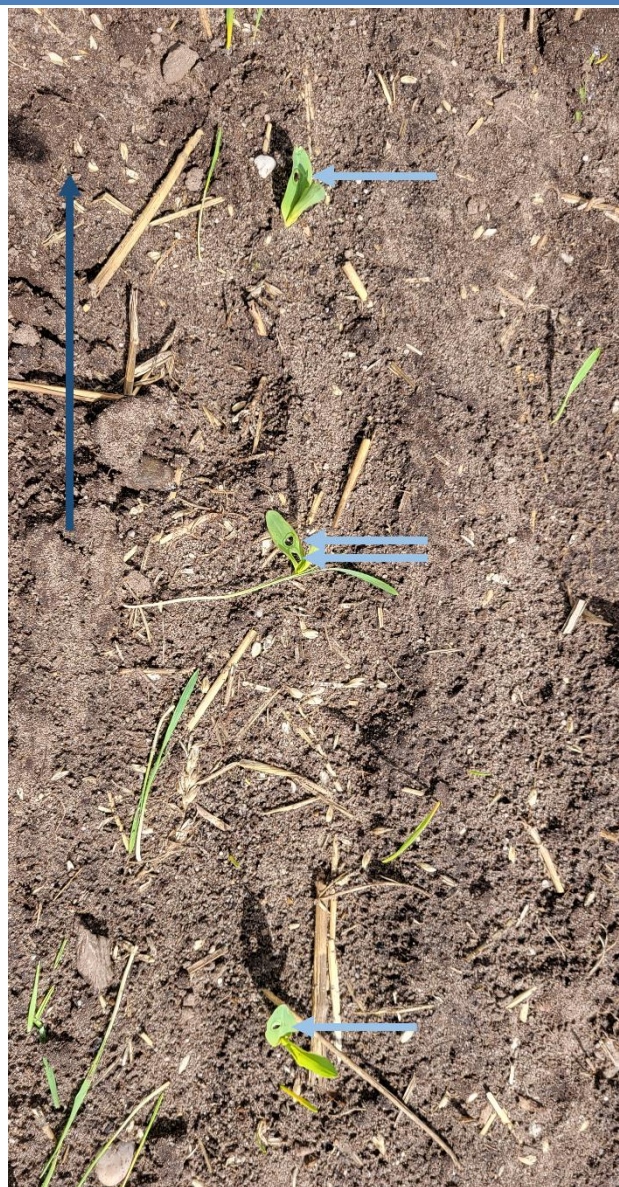
**Fig. 5.53. Hit marks of laser treatment (light blue arrows) on maize crops. This image was taken during the latency assessment of the system in Reusel to check and correctly set the latency between image acquisition and laser shot for compensation of forward movement. At this checking run, latency compensation was set too high, so all laser hits were shifted in the movement direction of the robot (dark blue arrow). Crop plants (maize) were hit deliberately to have a better check of the hit position in comparison to the narrow barley grass leaves.**

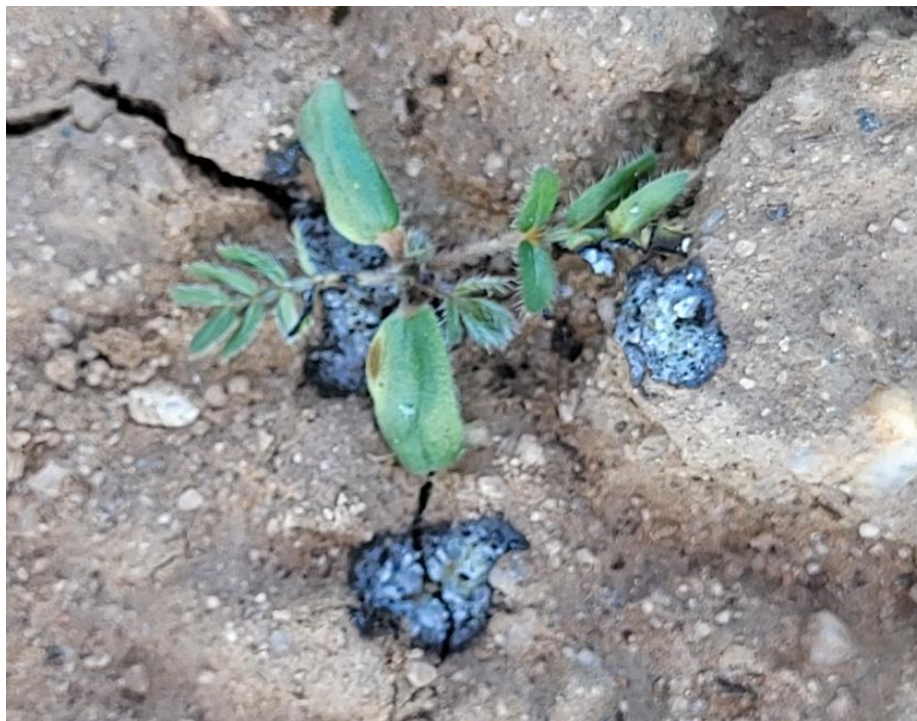
**Fig. 3.54. Multi-hit marks on and near to weed plants on the test site in Arganda del Rey showing the targeting accuracy under field conditions.**
